**CLIENT:** Sage Memorial Hospital  
SR 264 & Hwy 191  
Ganado, AZ 86505

**PROJECT:** Sage Memorial Hospital – Structural Investigation – Group Home Assessment

**PROJECT NO.:** 2026-008-001

**REPORT DATE:** March 5, 2026

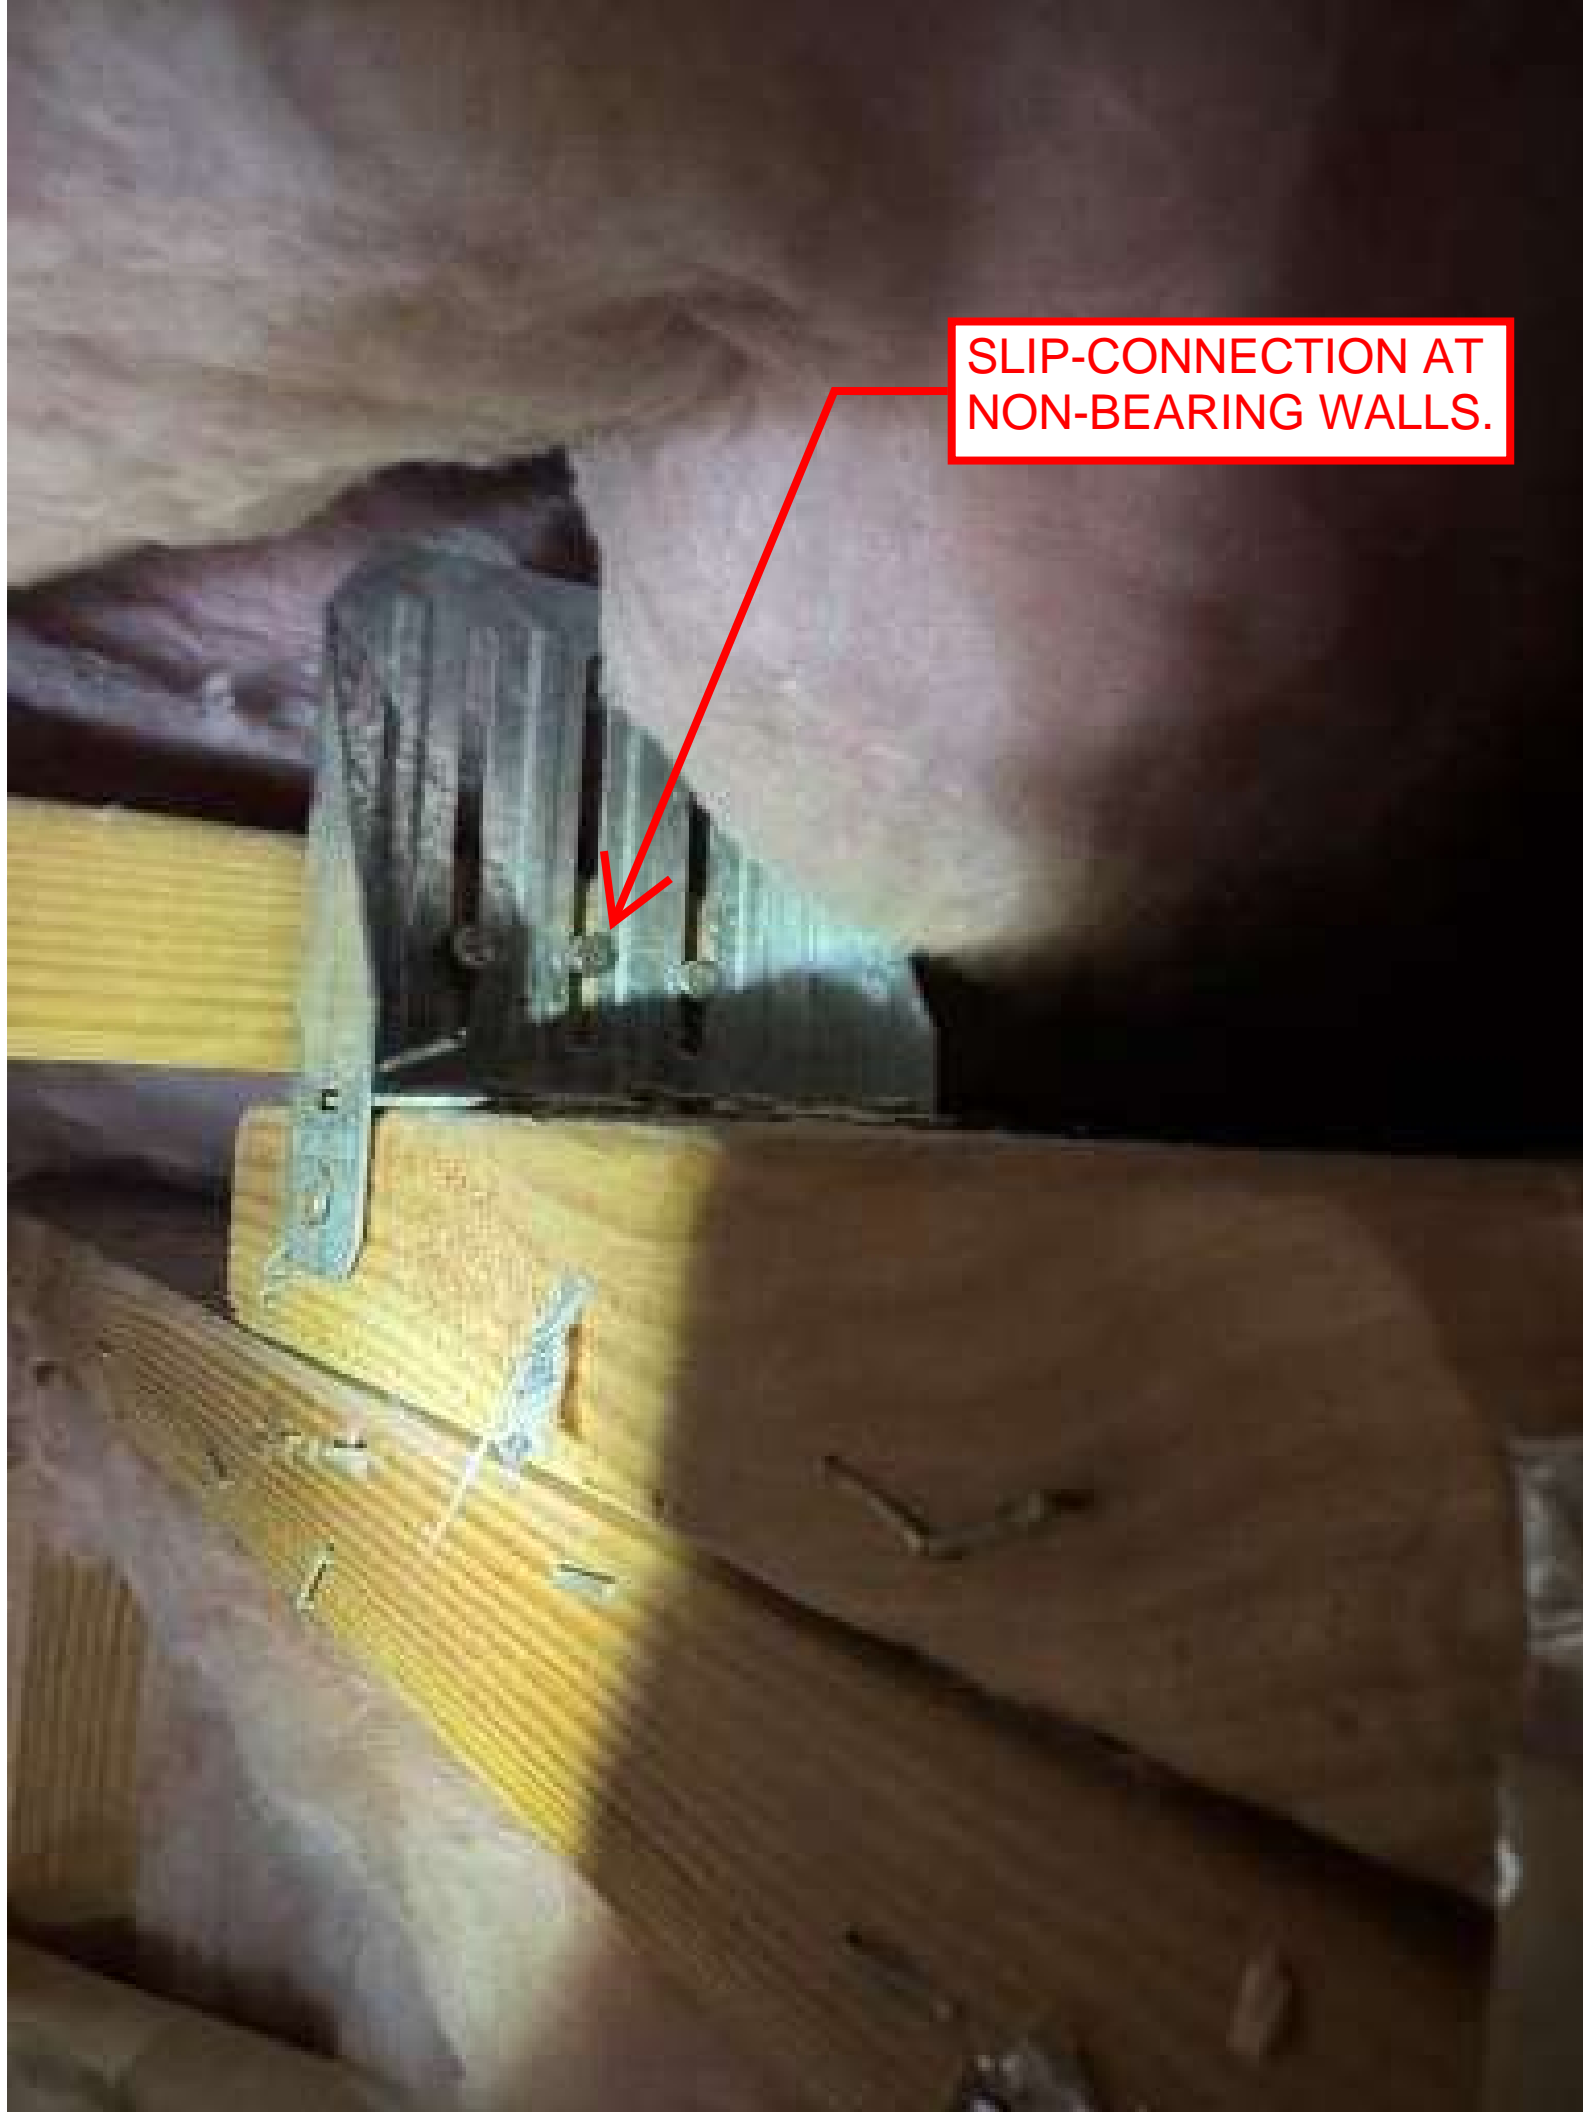
SLIP-CONNECTION AT  
NON-BEARING WALLS.

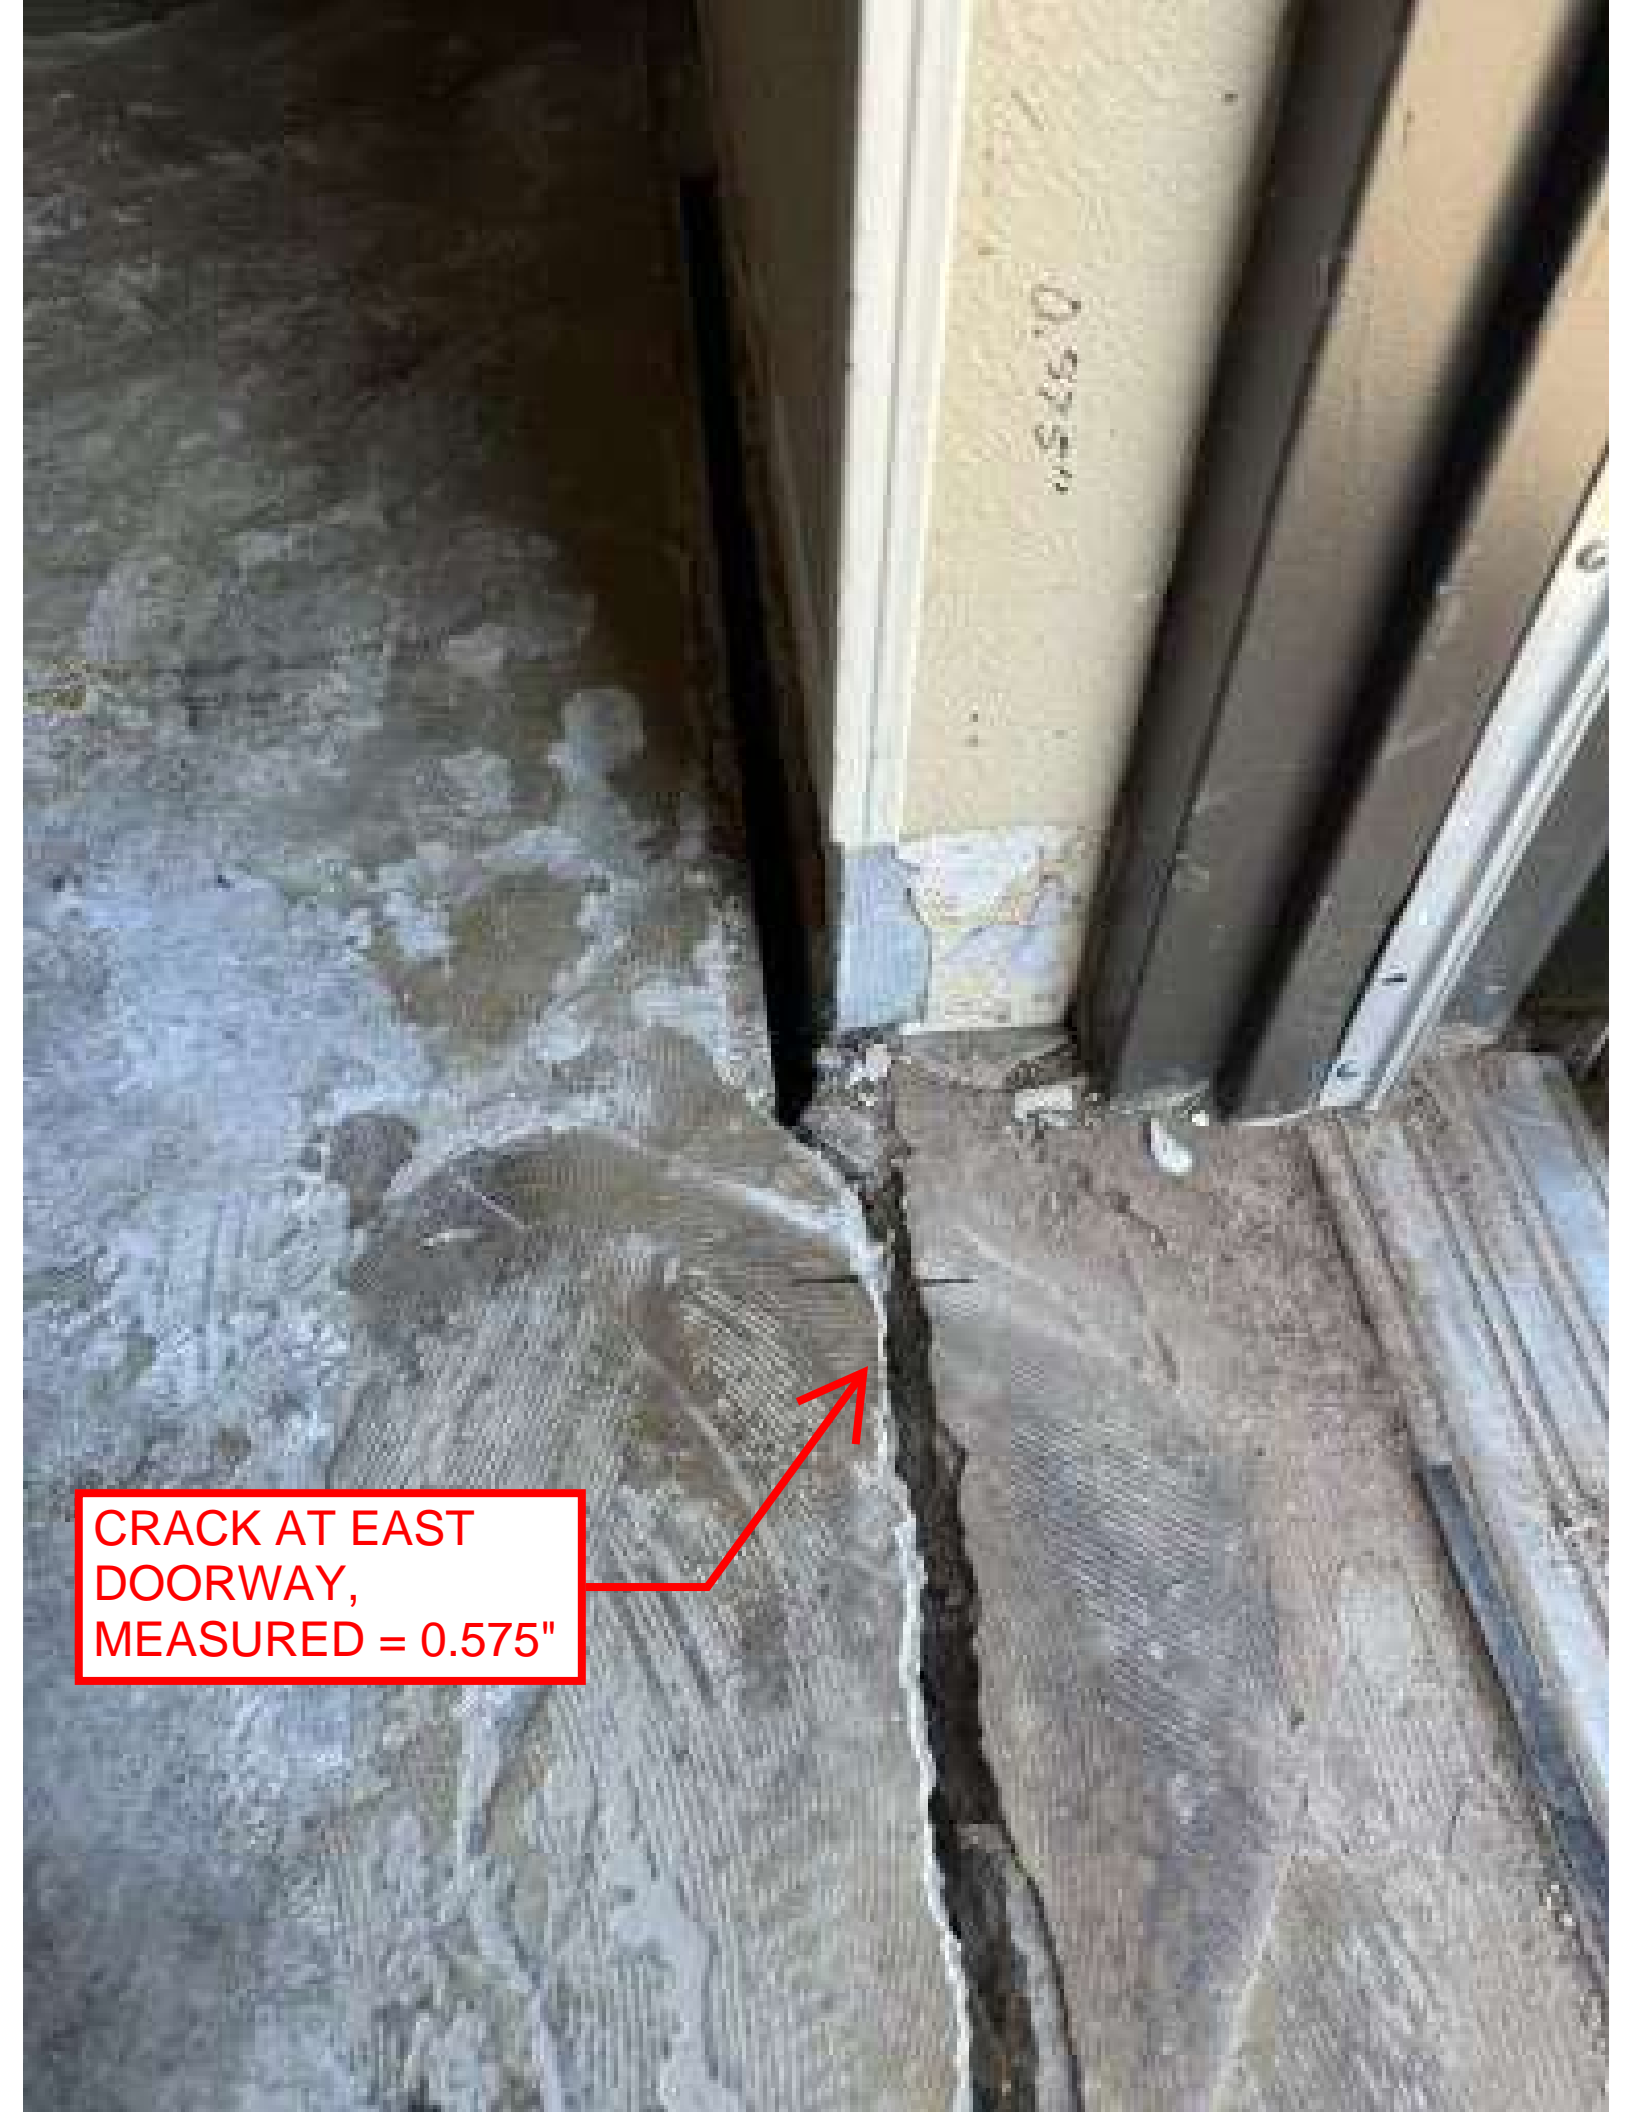
CRACK AT EAST  
DOORWAY,  
MEASURED = 0.575"

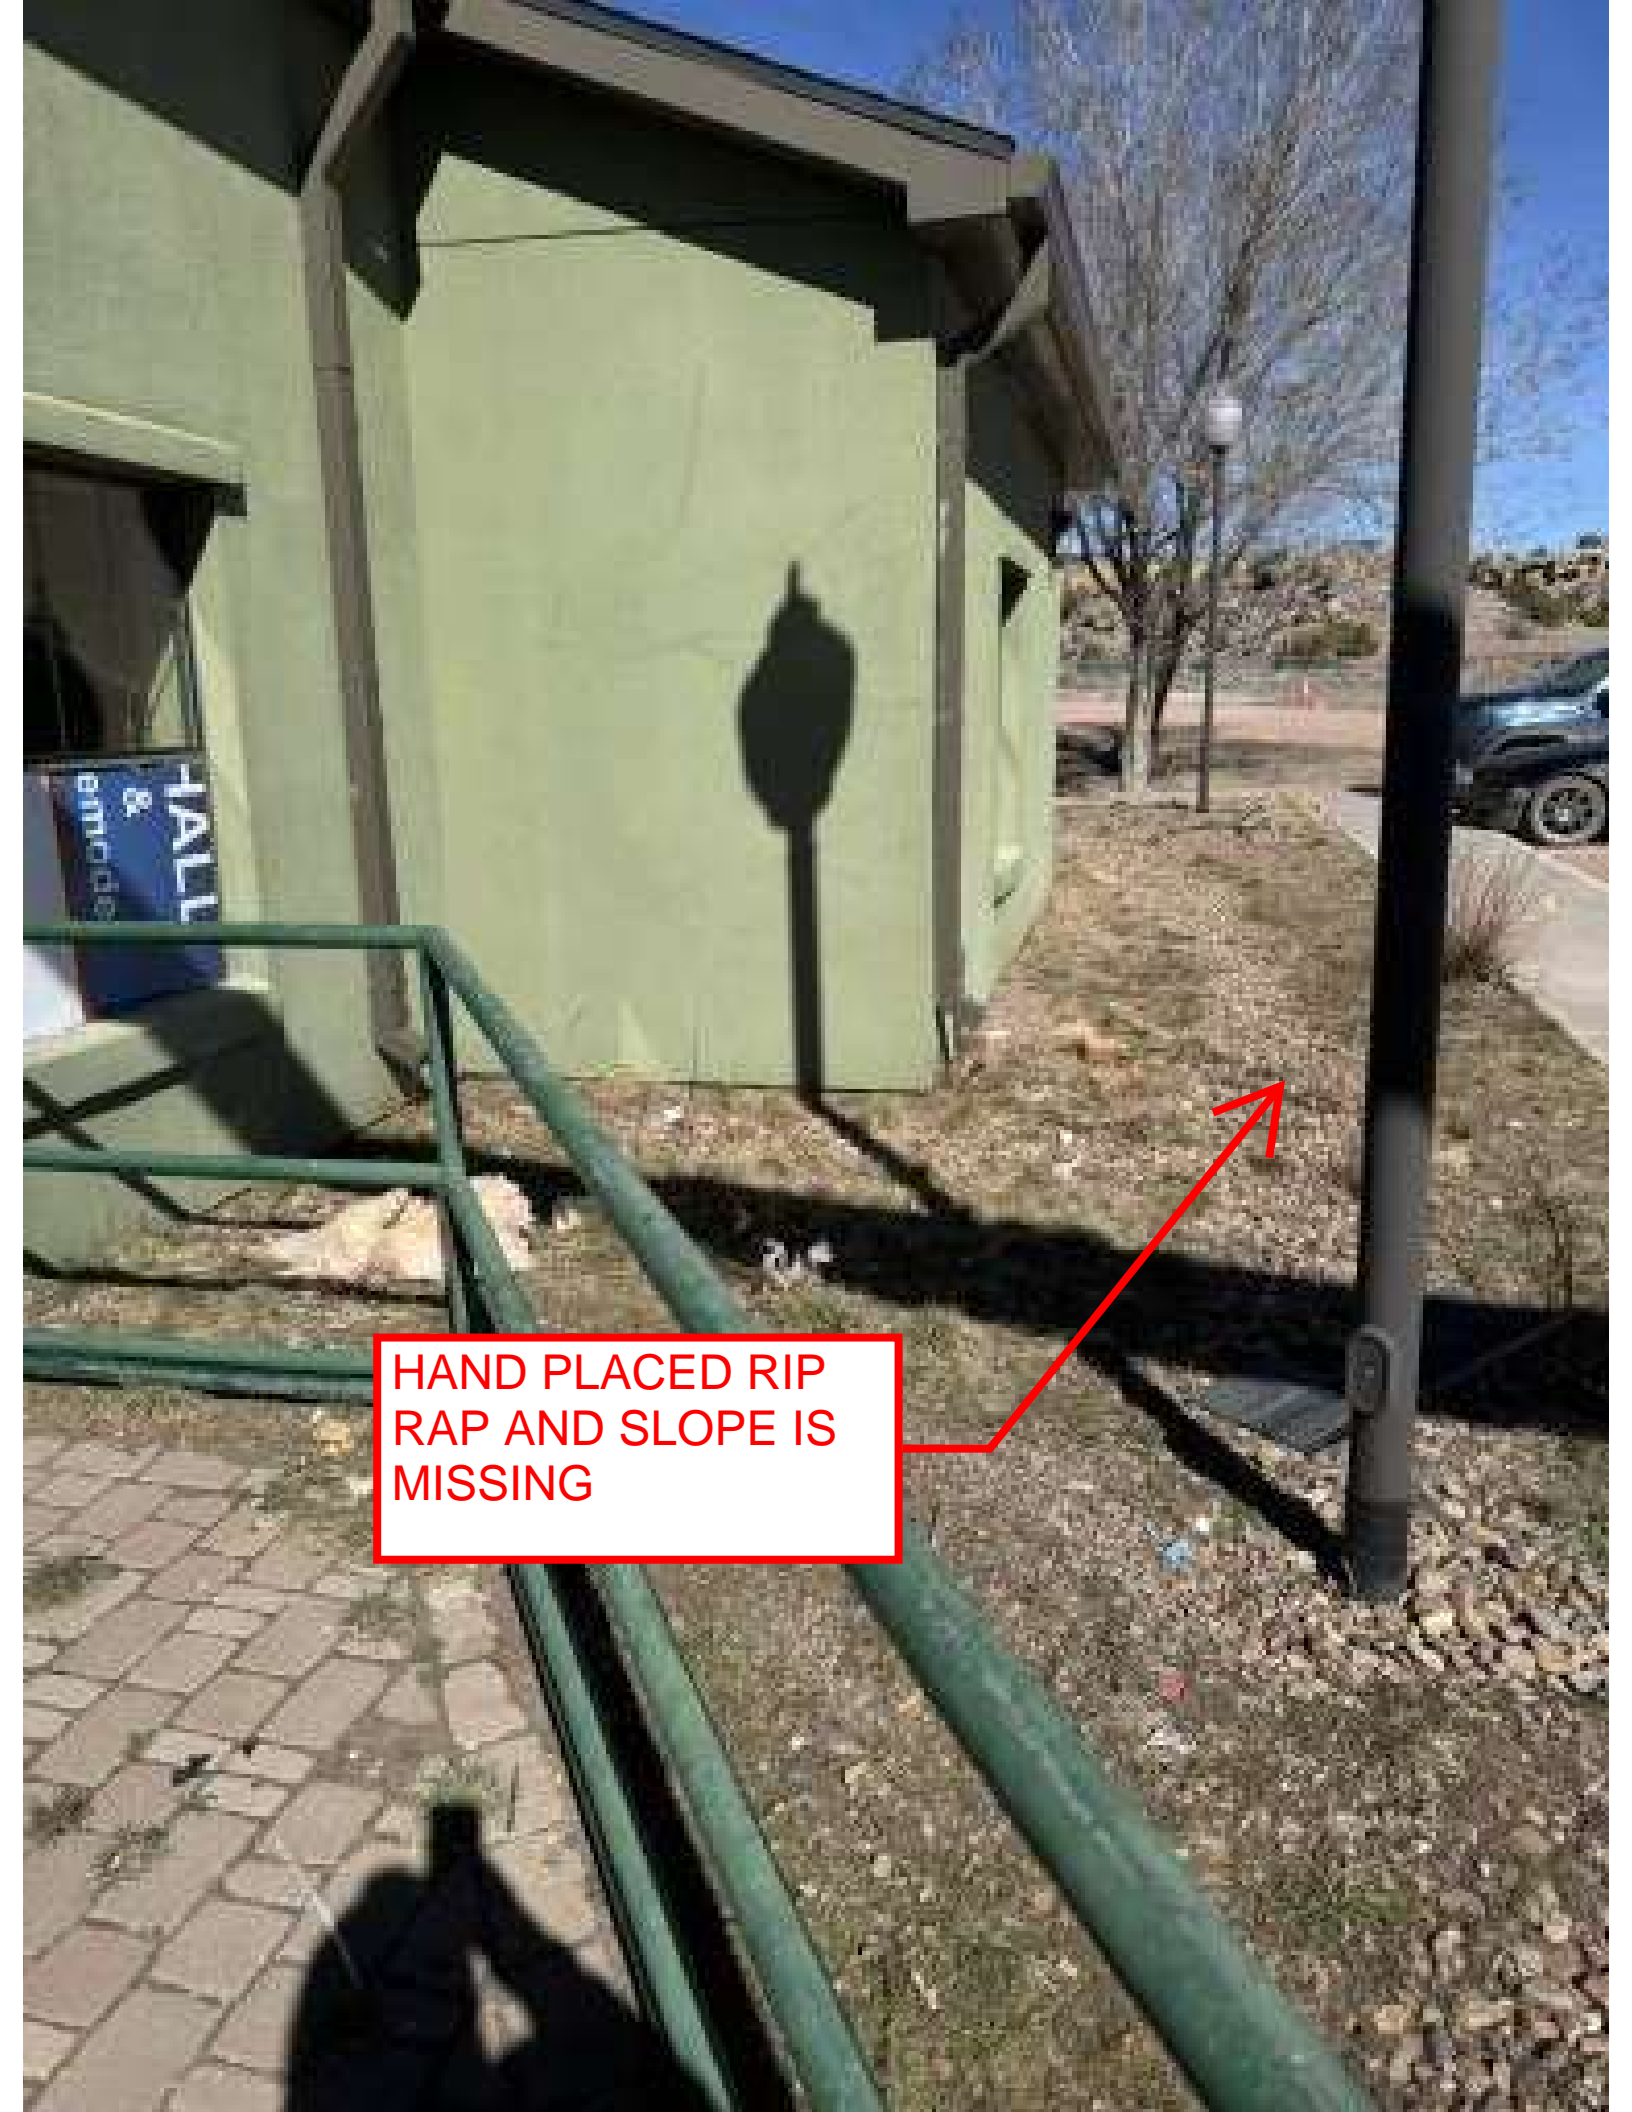
SOIL NOT DRAINING  
EXCESS WATER

HAND PLACED RIP RAP AND SLOPE IS MISSING

- WYCO E&C recommends installing perforated pipes along the North/West/East

landscaped areas, adjacent to the building. The existing dirt shall be compacted and sloping away from the building (at a minimum of 2% grade).

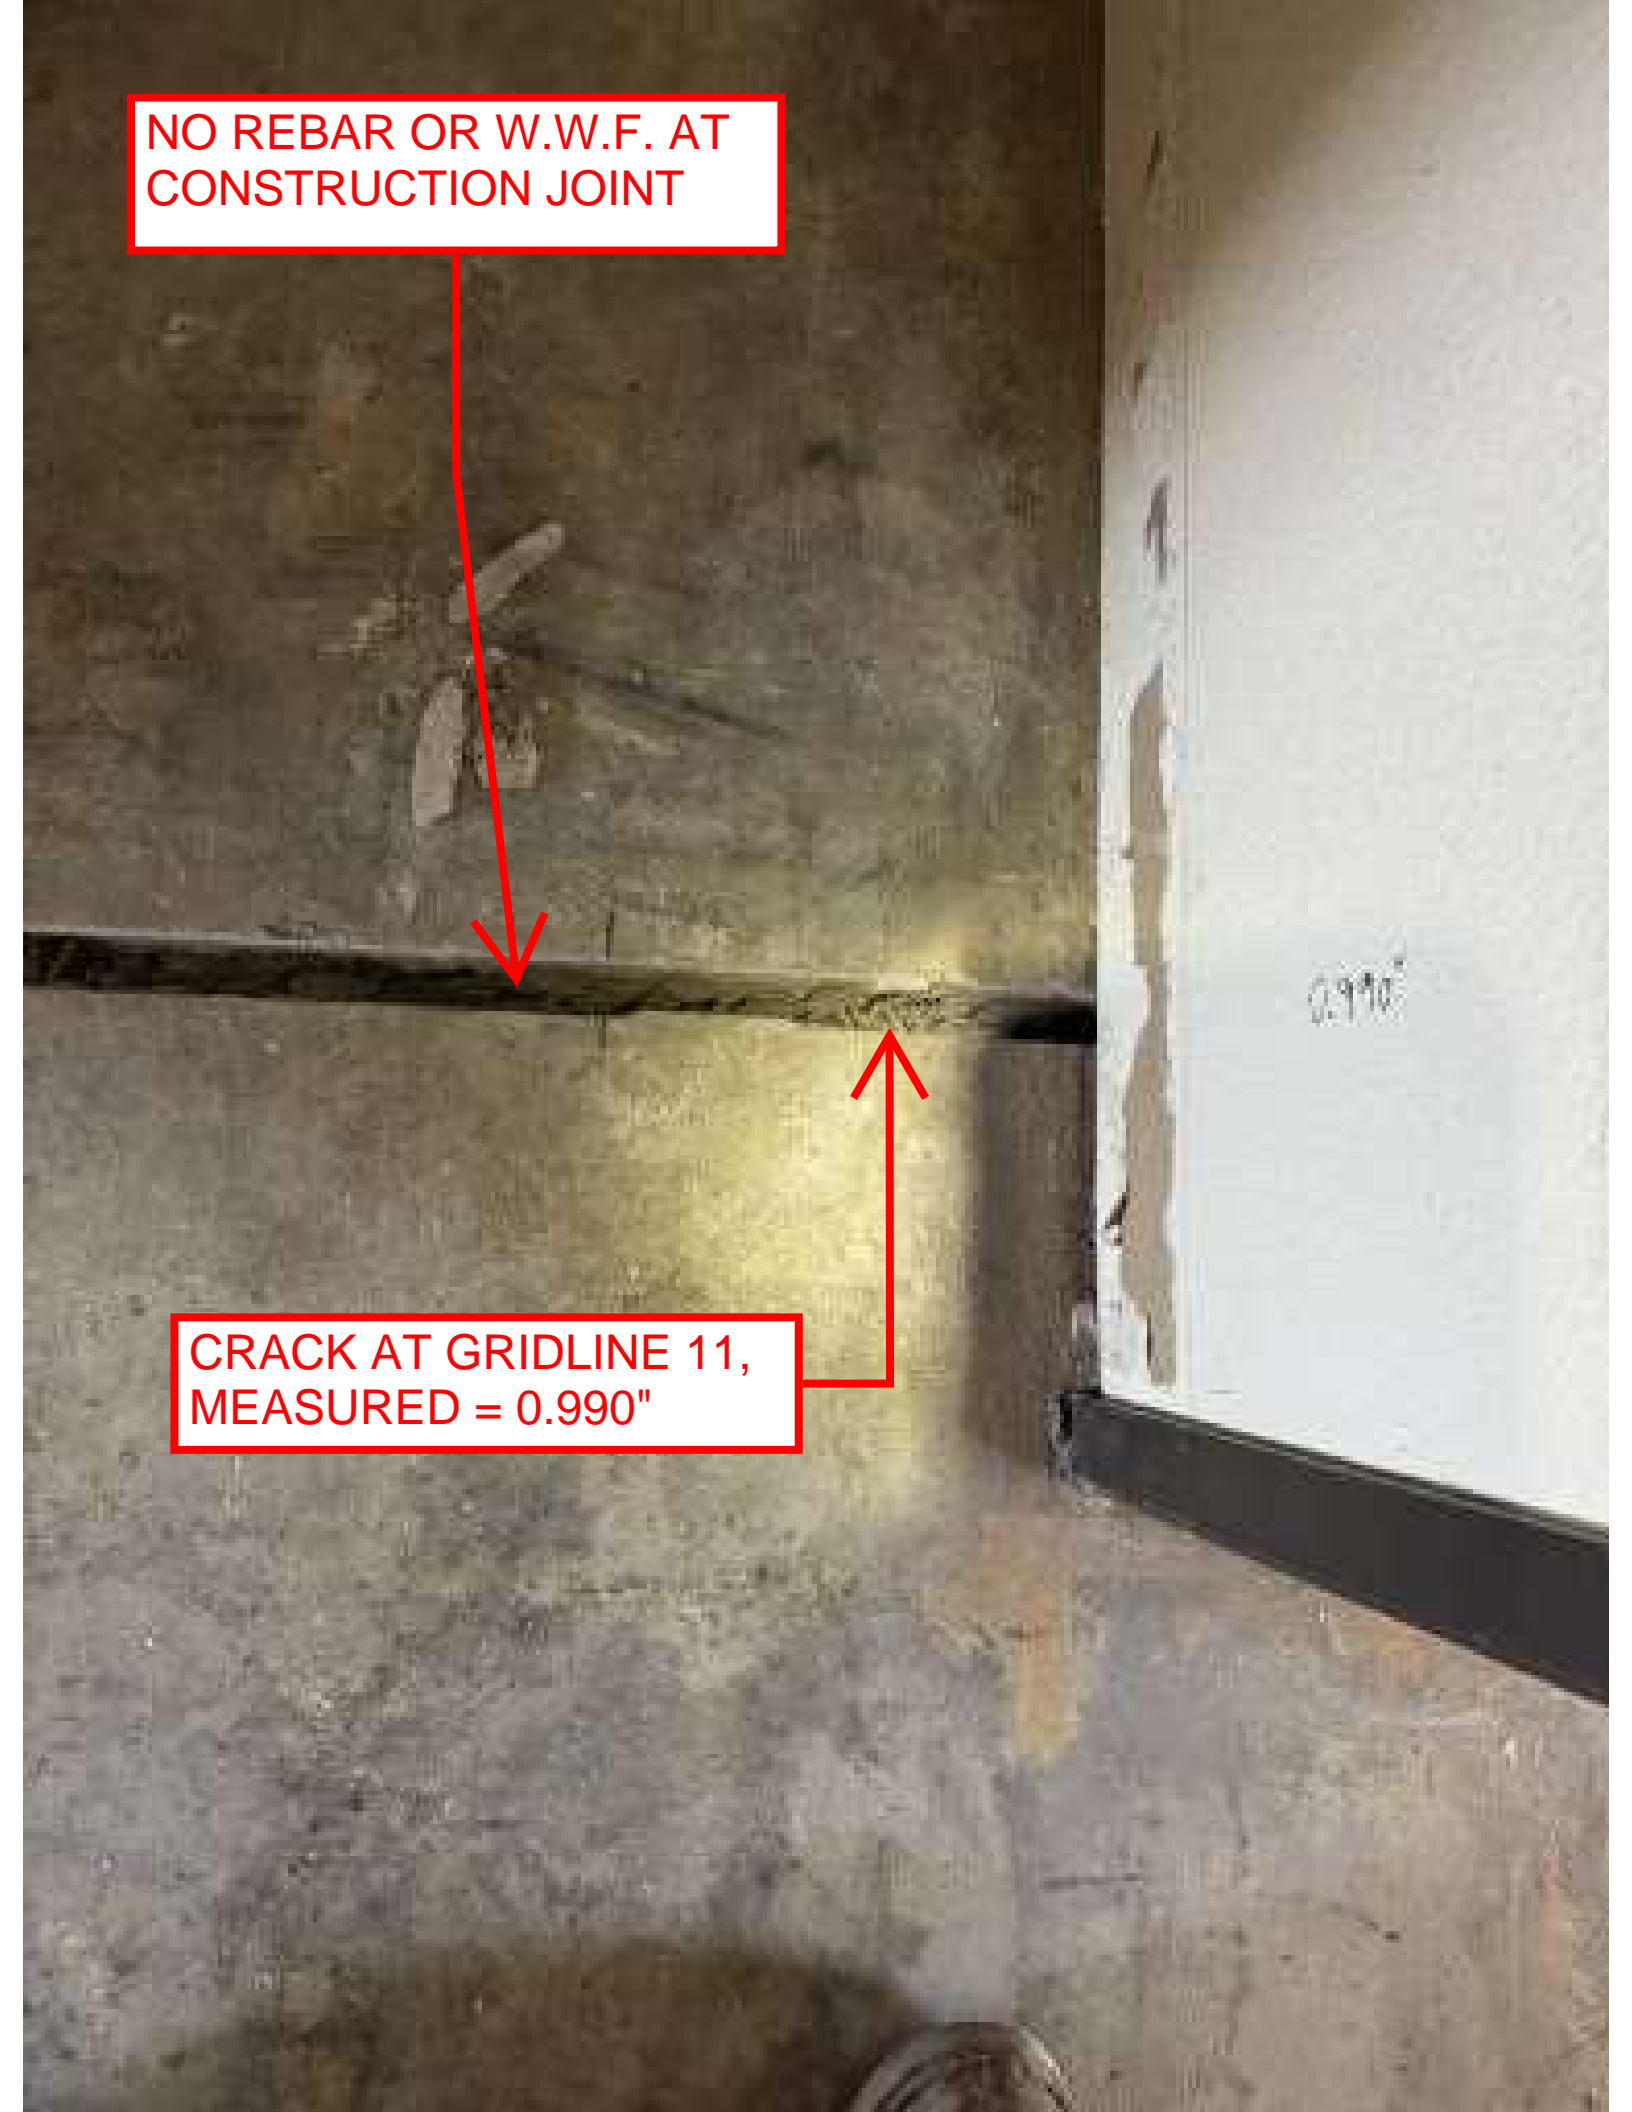
5. SOG cracking is occurring from western wall to eastern, along gridline 11, approximated 0.911" at time of site visit. The crack was measured and marked for further inspection. After removing debris and rocks at the crack, visual inspection shows the Construction Joint did not have any Welded Wire Fabric present but has a vapor barrier. Without the W.W.F., the lateral stability was eliminated. The W.W.F. provides structural stability for Thermal Expansion and Shrinkage (as required in ACI Code for minimum amount of steel in structural concrete concrete) for the slab-on-grade. The Slab is sliding away from each other at gridline 11. The Slab is not settled vertically, as the slab was measured with an 8ft level at several locations and is relatively flat.

NO REBAR OR W.W.F. AT  
CONSTRUCTION JOINT

CRACK AT GRIDLINE 11,  
MEASURED = 0.990"

- The crack at gridline will have to be sawcut and removed, a minimum of 2ft wide (along gridline) x 1ft deep, length of wall (approximately 41 ft of length).

- See attached sketch for the turndown and requirements for reconnecting the slab. The slab demolition and repair shall be completed after stem walls fix has been completed.

- The existing soil shall be compacted with a mechanical compactor.
  - The contractor shall report to WYCO how much the crack has moved or if the crack has closed.

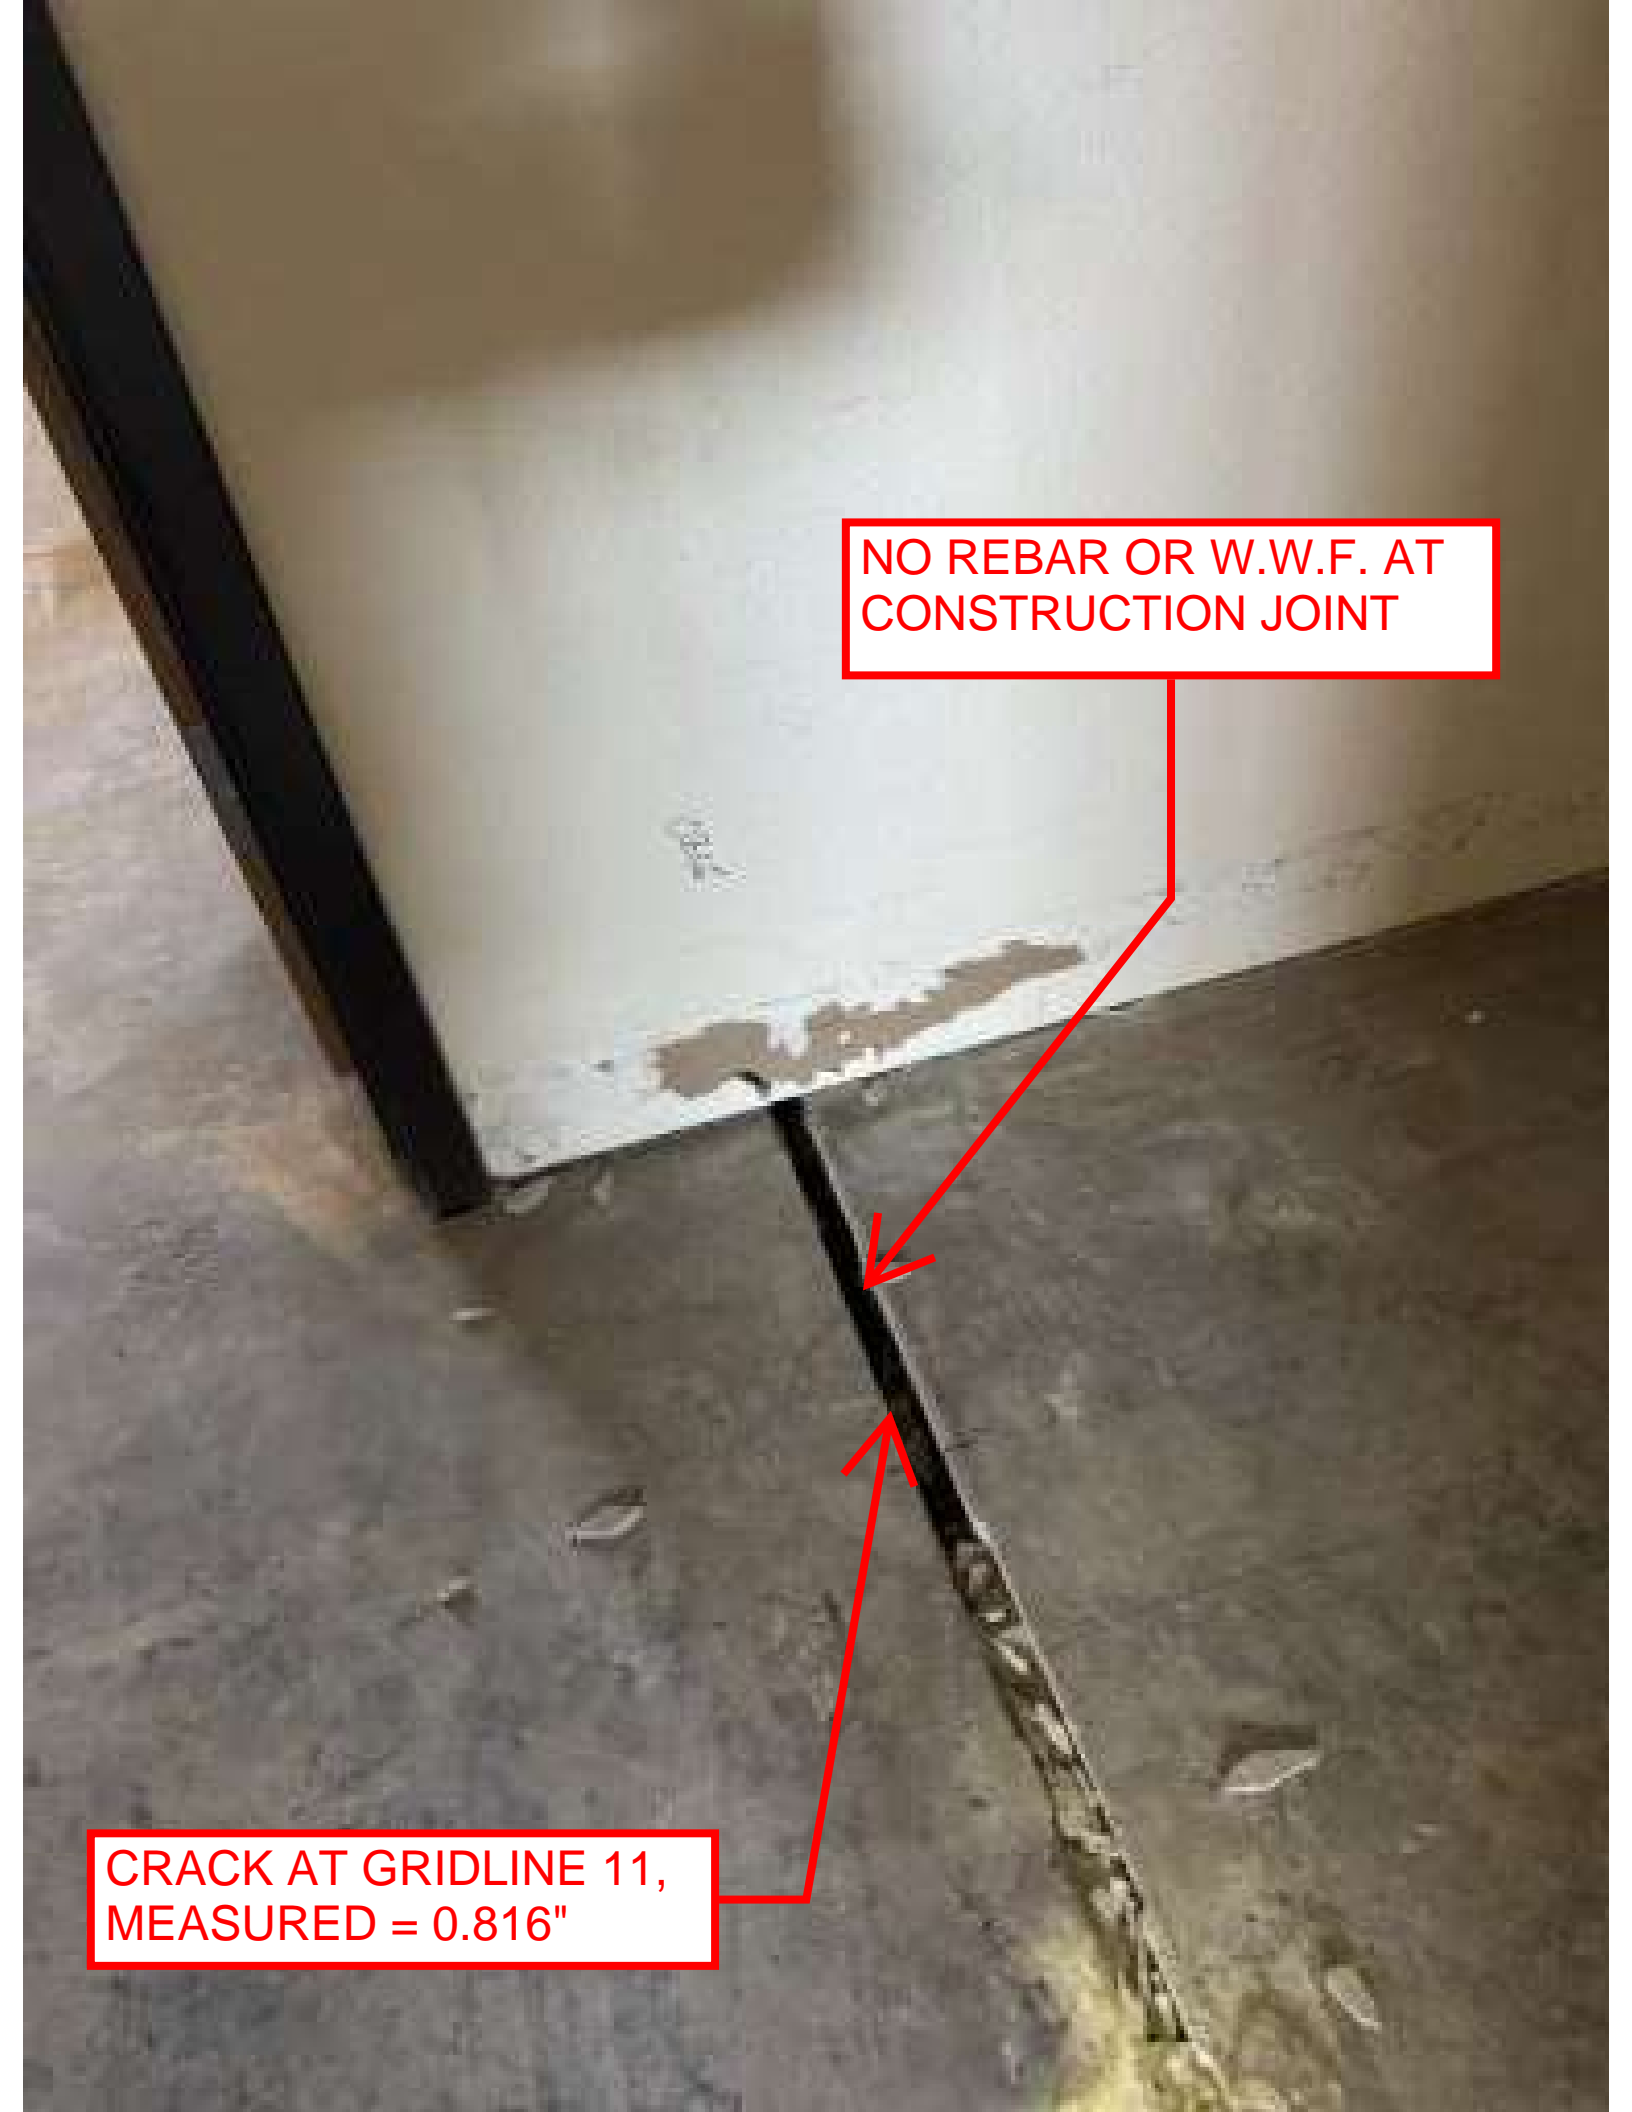
NO REBAR OR W.W.F. AT CONSTRUCTION JOINT

CRACK AT GRIDLINE 11,  
MEASURED = 0.816"

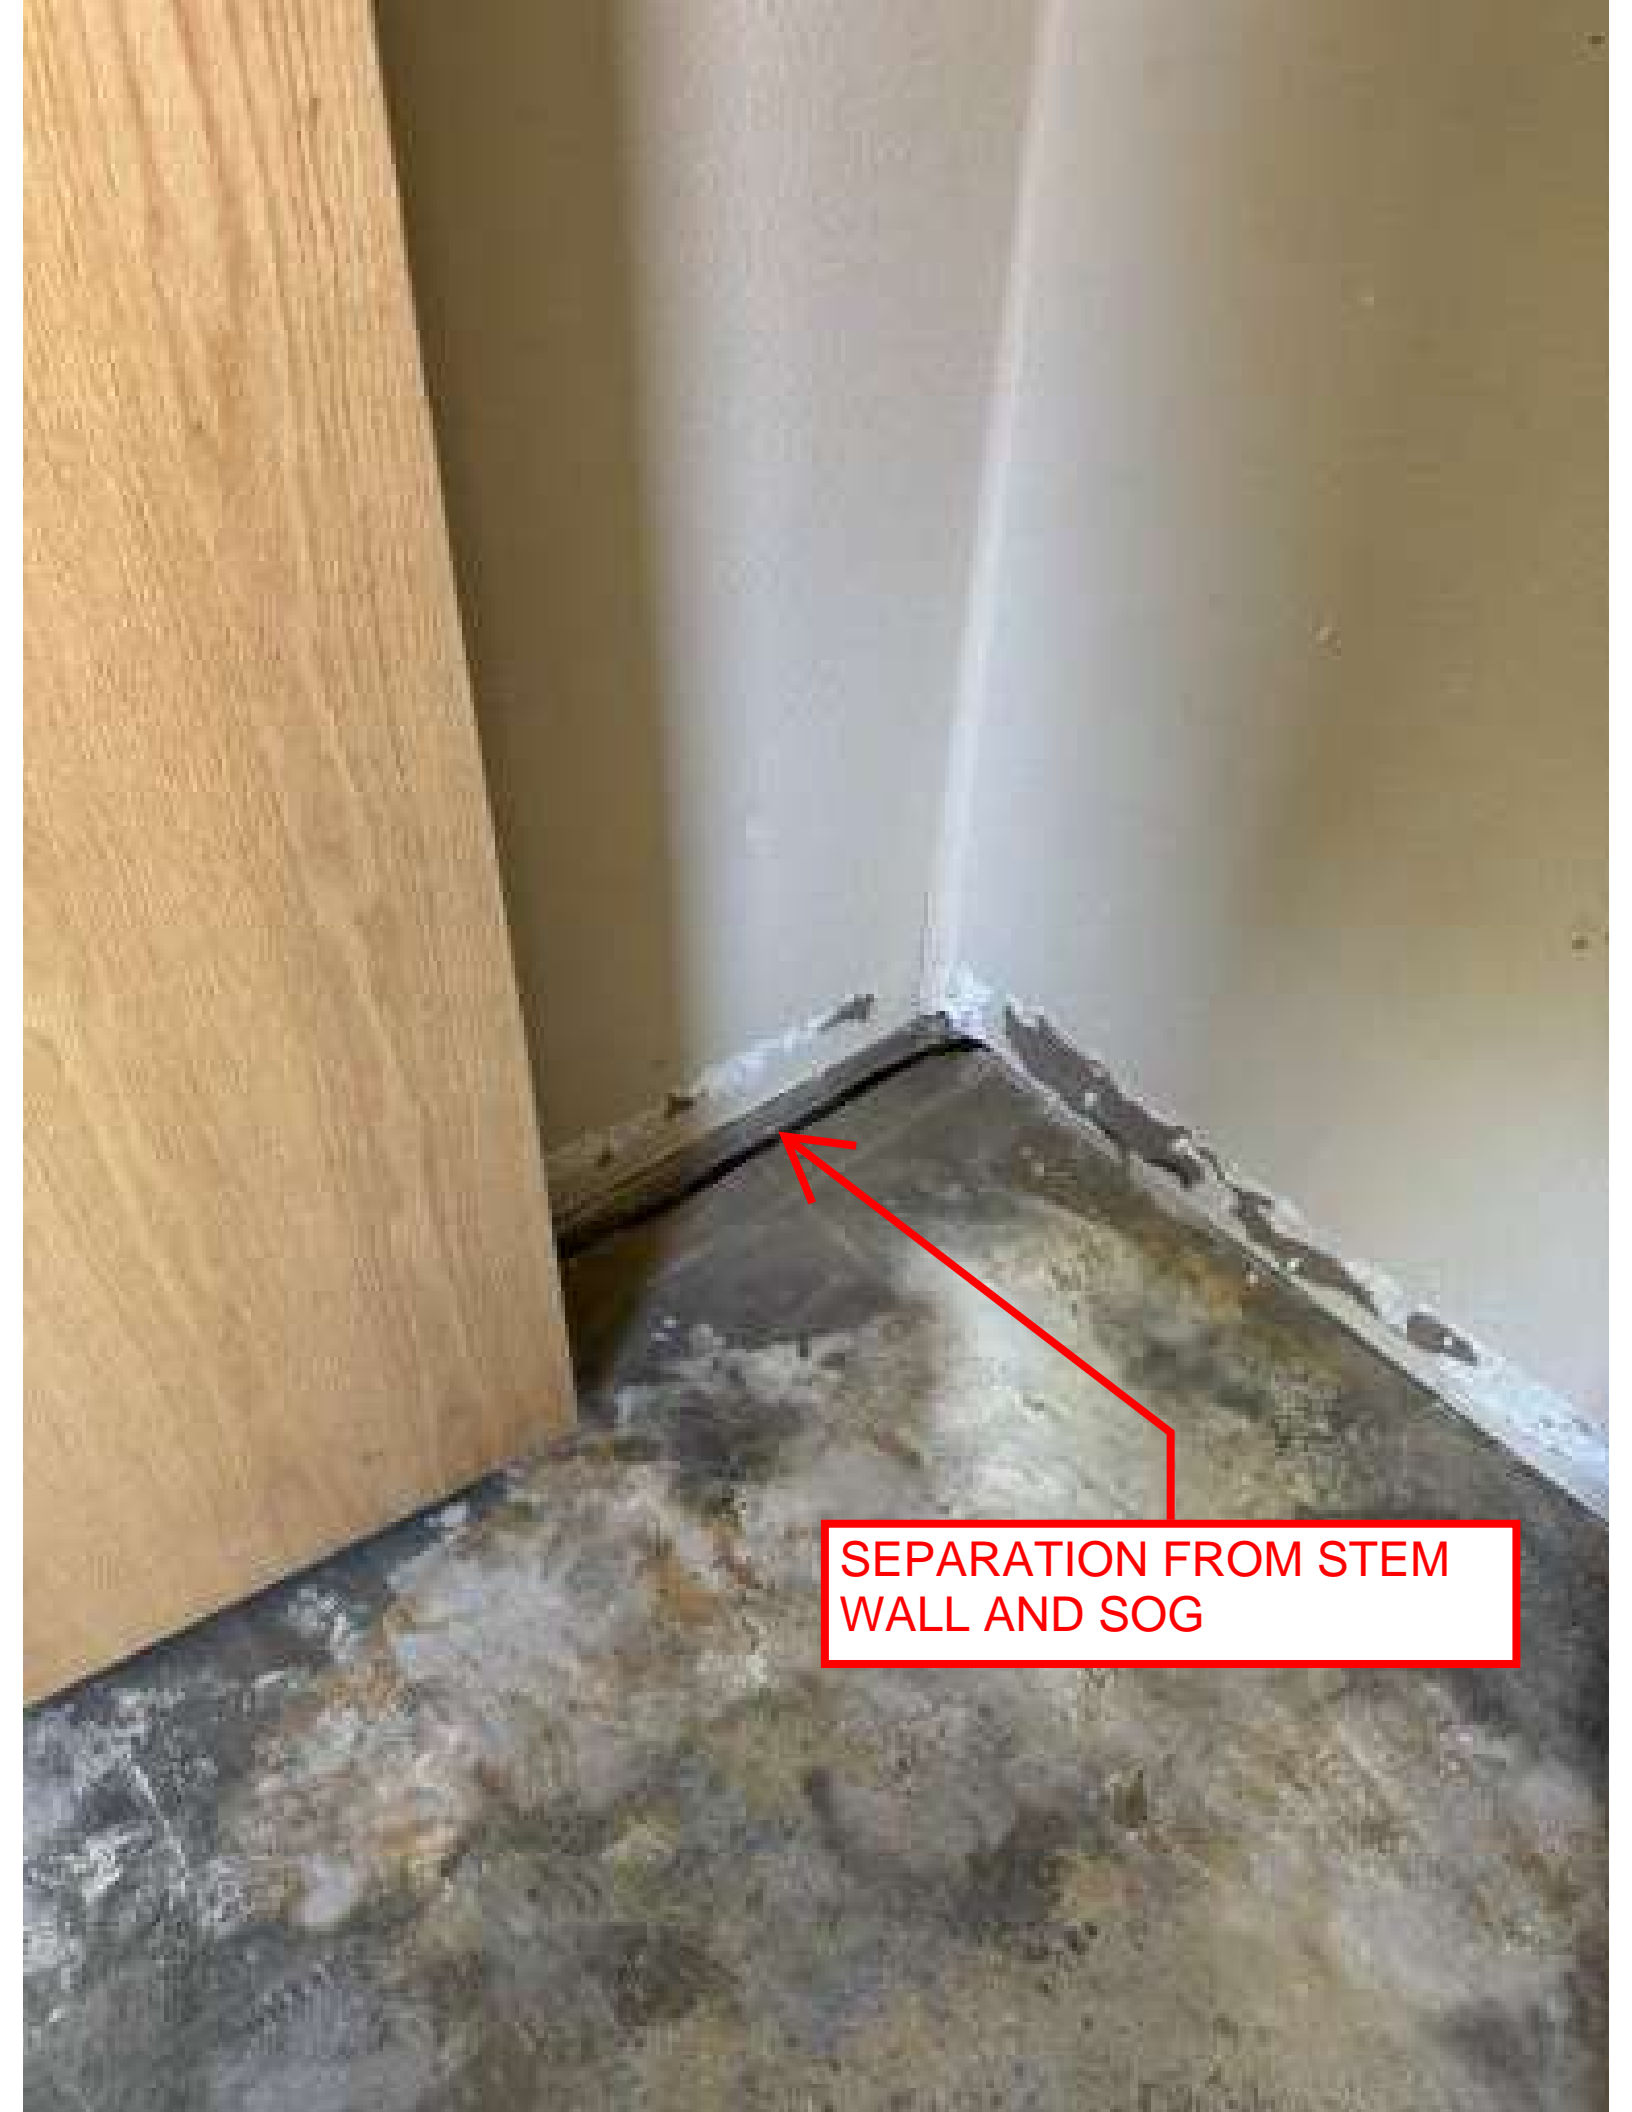
- Visual inspection identified separation of the slab-on-grade along Gridline 11, see photos (Ganado site).
- The ICF Walls bear on an 8" concrete stem wall and footings. There is large separation from the slab and the stem wall.

SEPARATION FROM STEM  
WALL AND SOG

1. Concrete Stem Wall/SOG Gap Condition: See Sketch
  - The exterior of the building will need to dug out and demolition of existing sidewalk will be required for fix. The Concrete Stem Wall will then be drilled through and a minimum of 6" in the Slabs Toe-Down and infilled with Structural Epoxy. Next, a 5/8" diameter threaded rod will need to be installed, minimum embedment of 6" will be required, and WYCO E&C require \*SSI Report for proper installation of epoxy. After the epoxy has cured, a washer and nut will be installed and torqued to close the Wall and SOG. All metals shall be galvanized to prevent any rust.
