**CLIENT:** Sage Memorial Hospital  
SR 264 & Hwy 191  
Ganado, AZ 86505

**PROJECT:** Sage Memorial Hospital – Structural Investigation – Group Home Assessment

**PROJECT NO.:** 2026-008-001

**REPORT DATE:** March 5, 2026

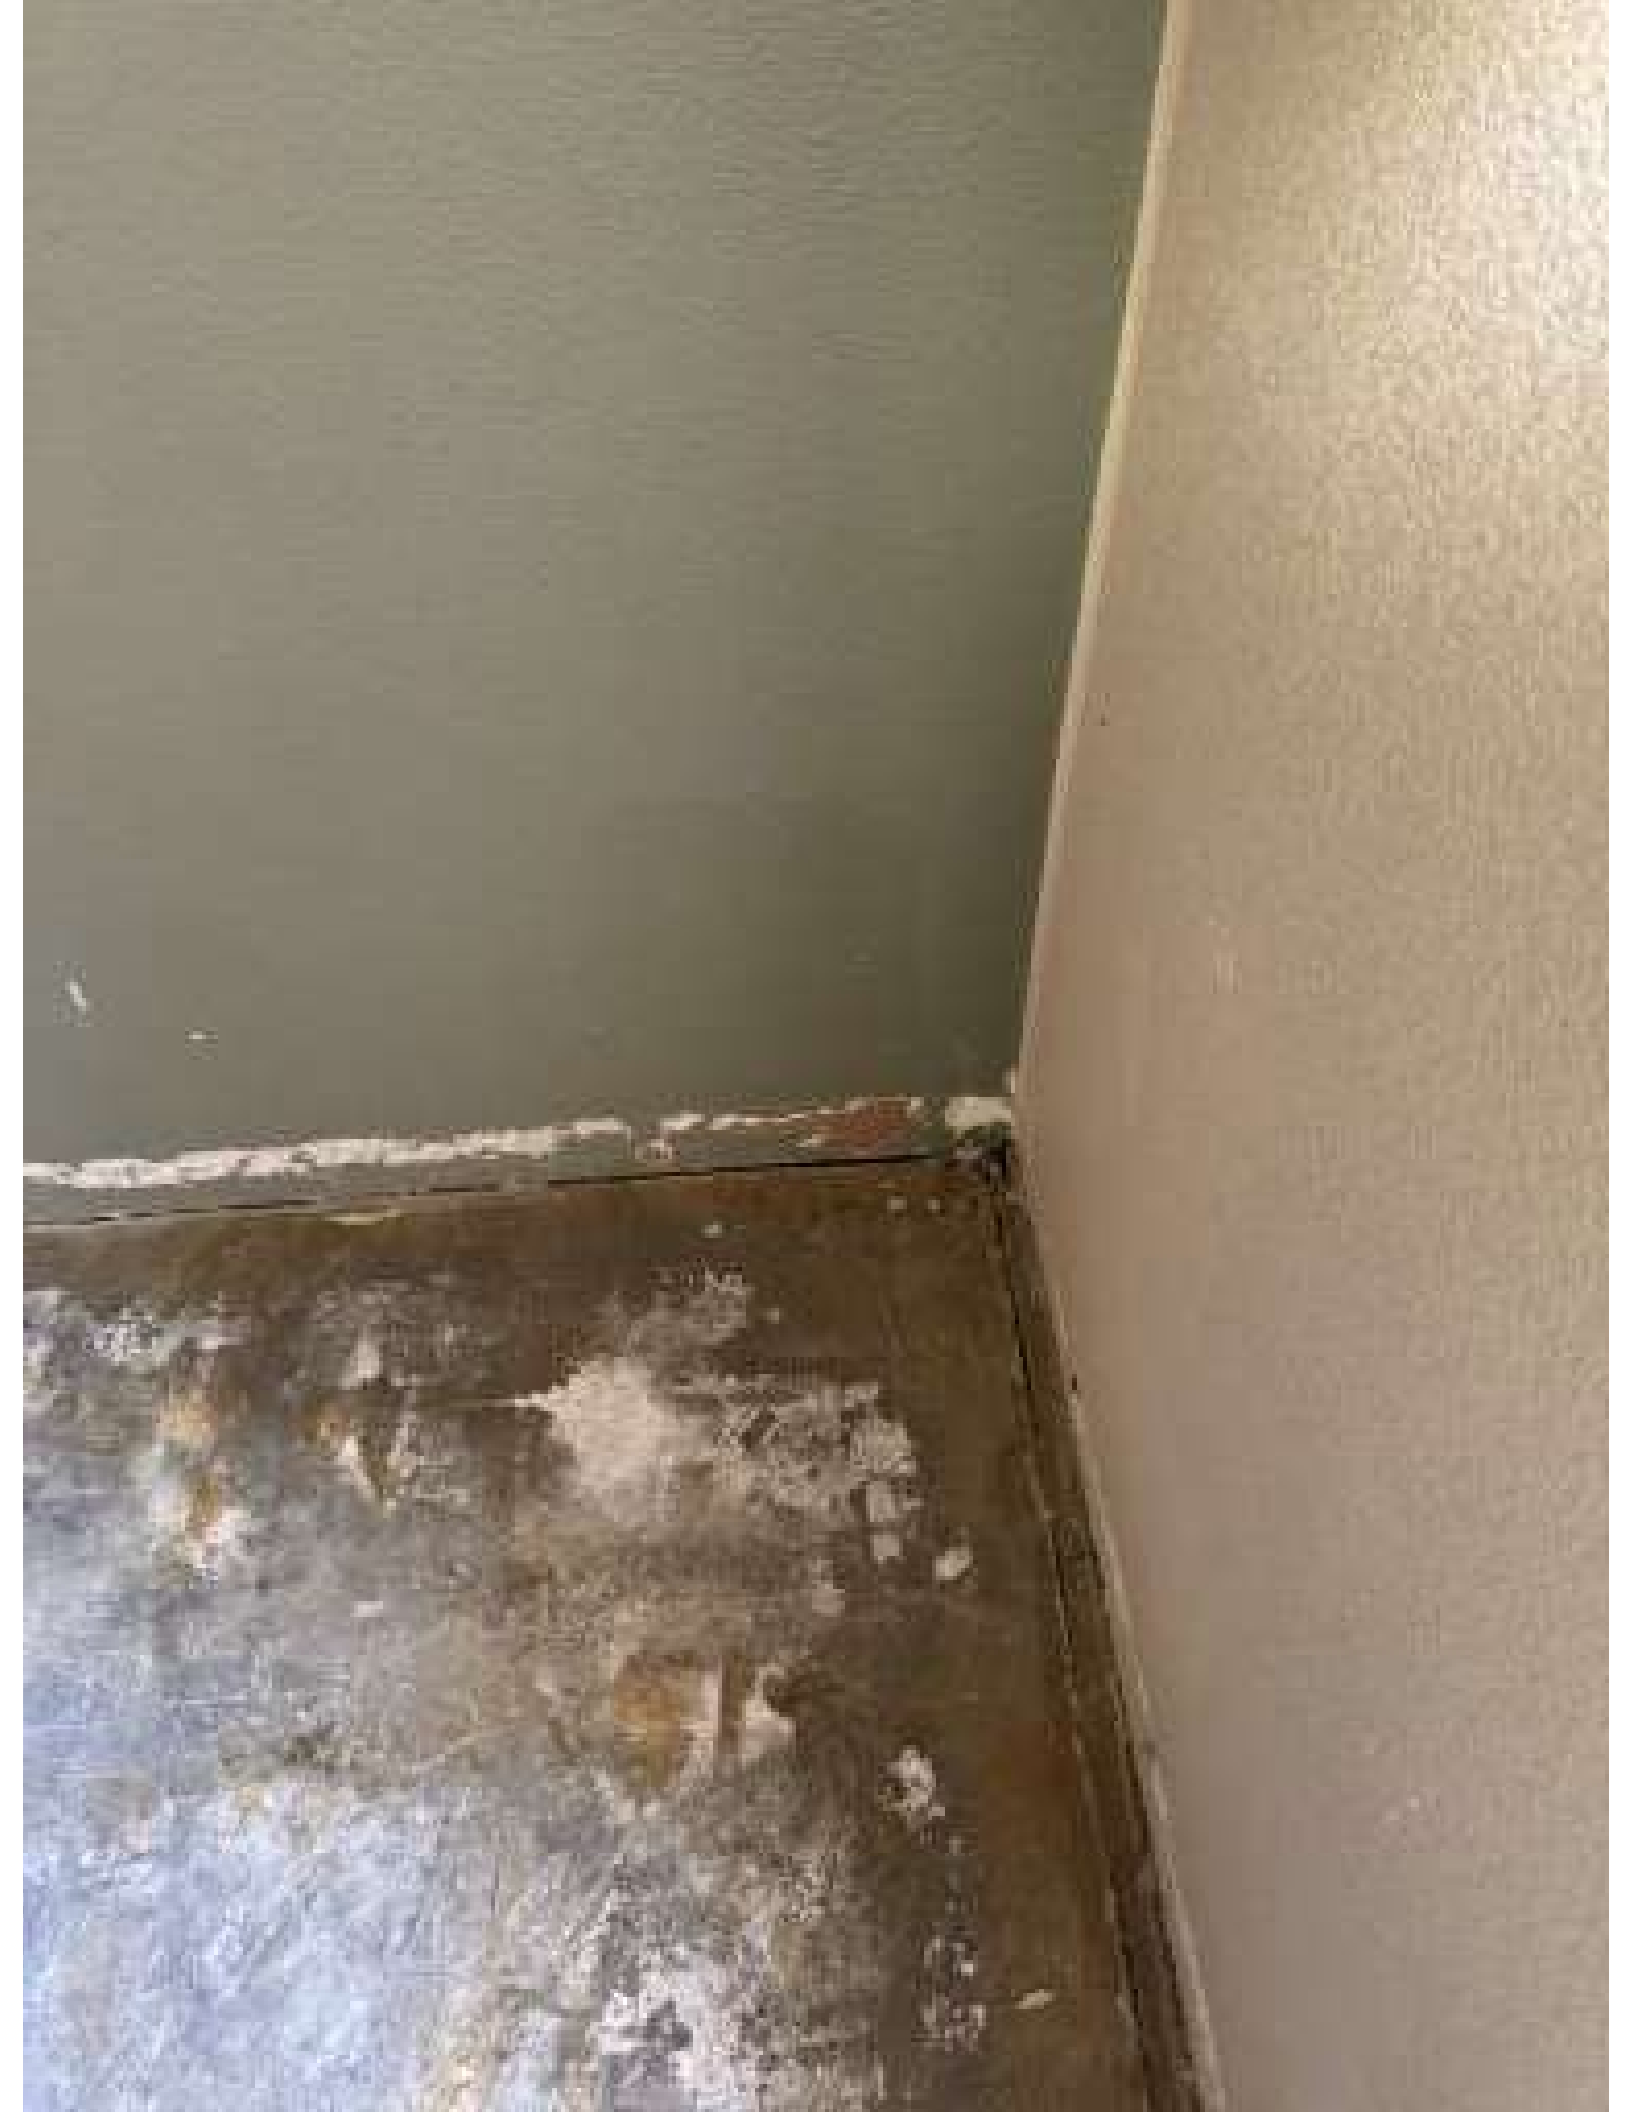
- Visual inspection identified separation of the slab-on-grade along Gridline 11, see photos (Ganado site).
- The ICF Walls bear on an 8" concrete stem wall and footings. There is large separation from the slab and the stem wall.

SEPARATION FROM STEM  
WALL AND SOG

1. Concrete Stem Wall/SOG Gap Condition: See Sketch
  - The exterior of the building will need to dug out and demolition of existing sidewalk will be required for fix. The Concrete Stem Wall will then be drilled through and a minimum of 6" in the Slabs Toe-Down and infilled with Structural Epoxy. Next, a 5/8" diameter threaded rod will need to be installed, minimum embedment of 6" will be required, and WYCO E&C require \*SSI Report for proper installation of epoxy. After the epoxy has cured, a washer and nut will be installed and torqued to close the Wall and SOG. All metals shall be galvanized to prevent any rust.

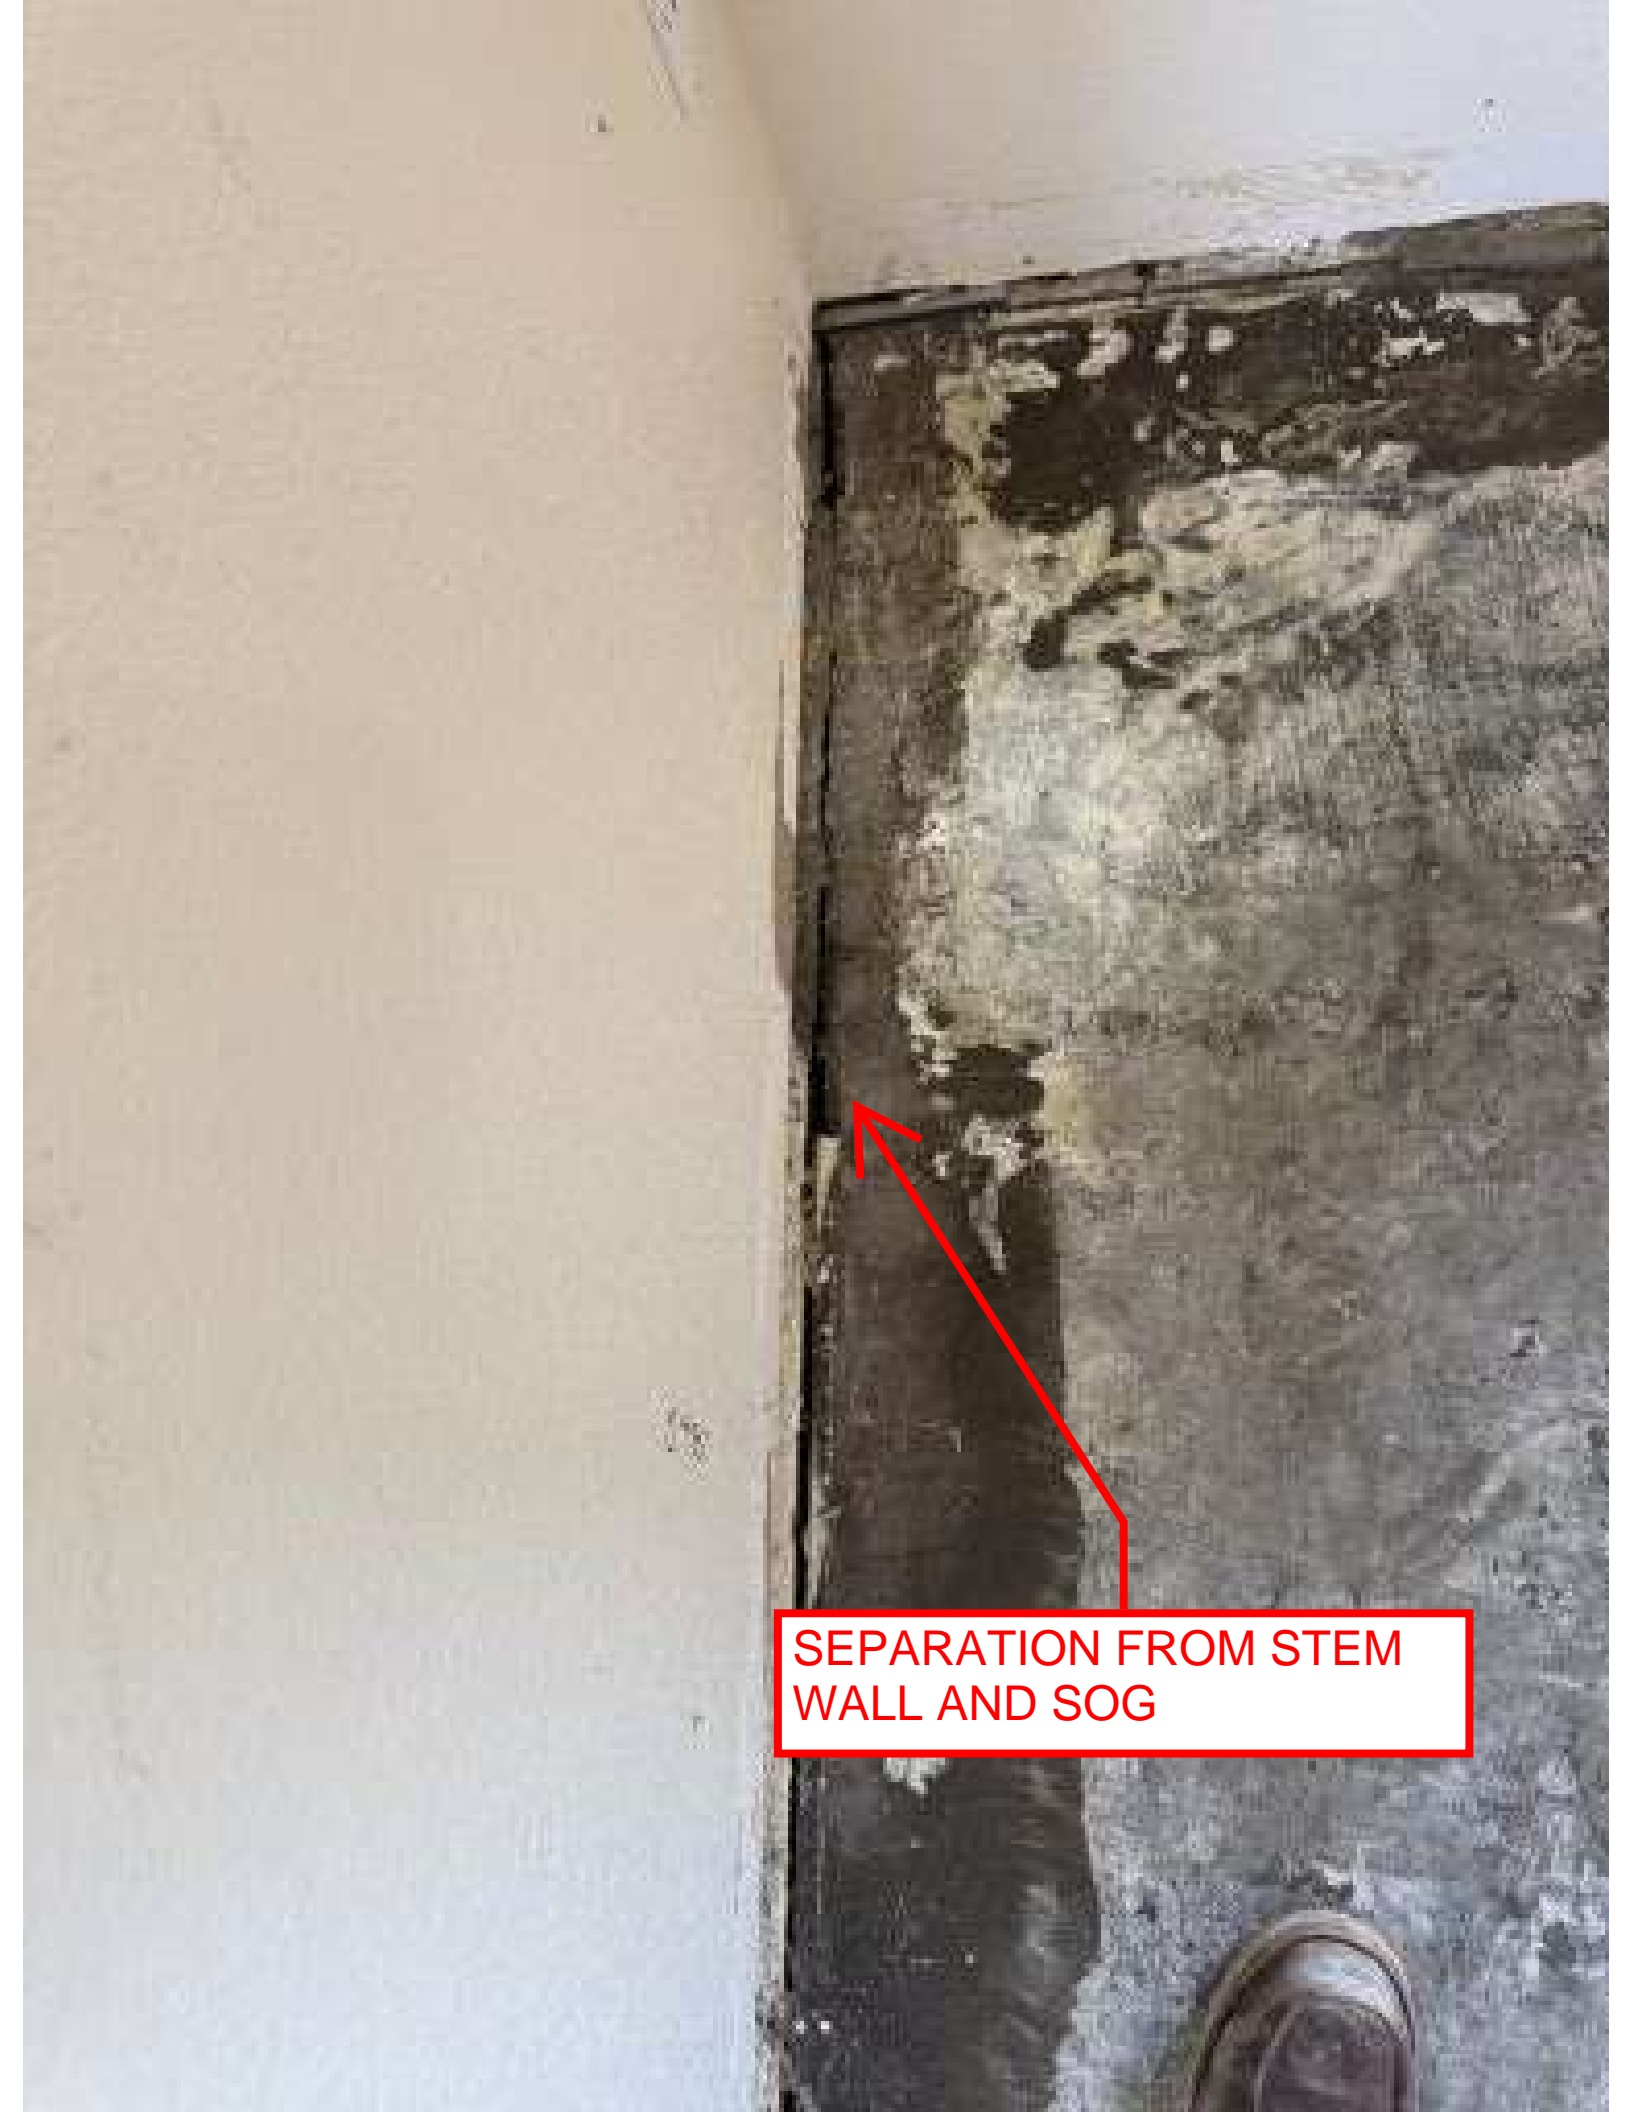
SEPARATION FROM STEM  
WALL AND SOG

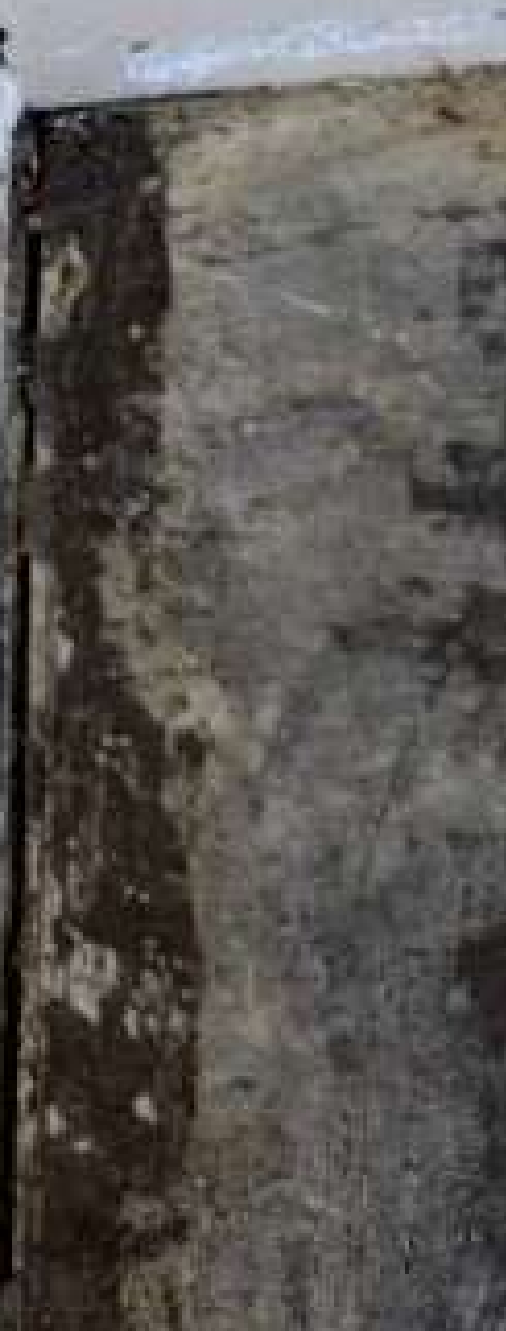
SEPARATION FROM STEM  
WALL AND SOG

0.66%

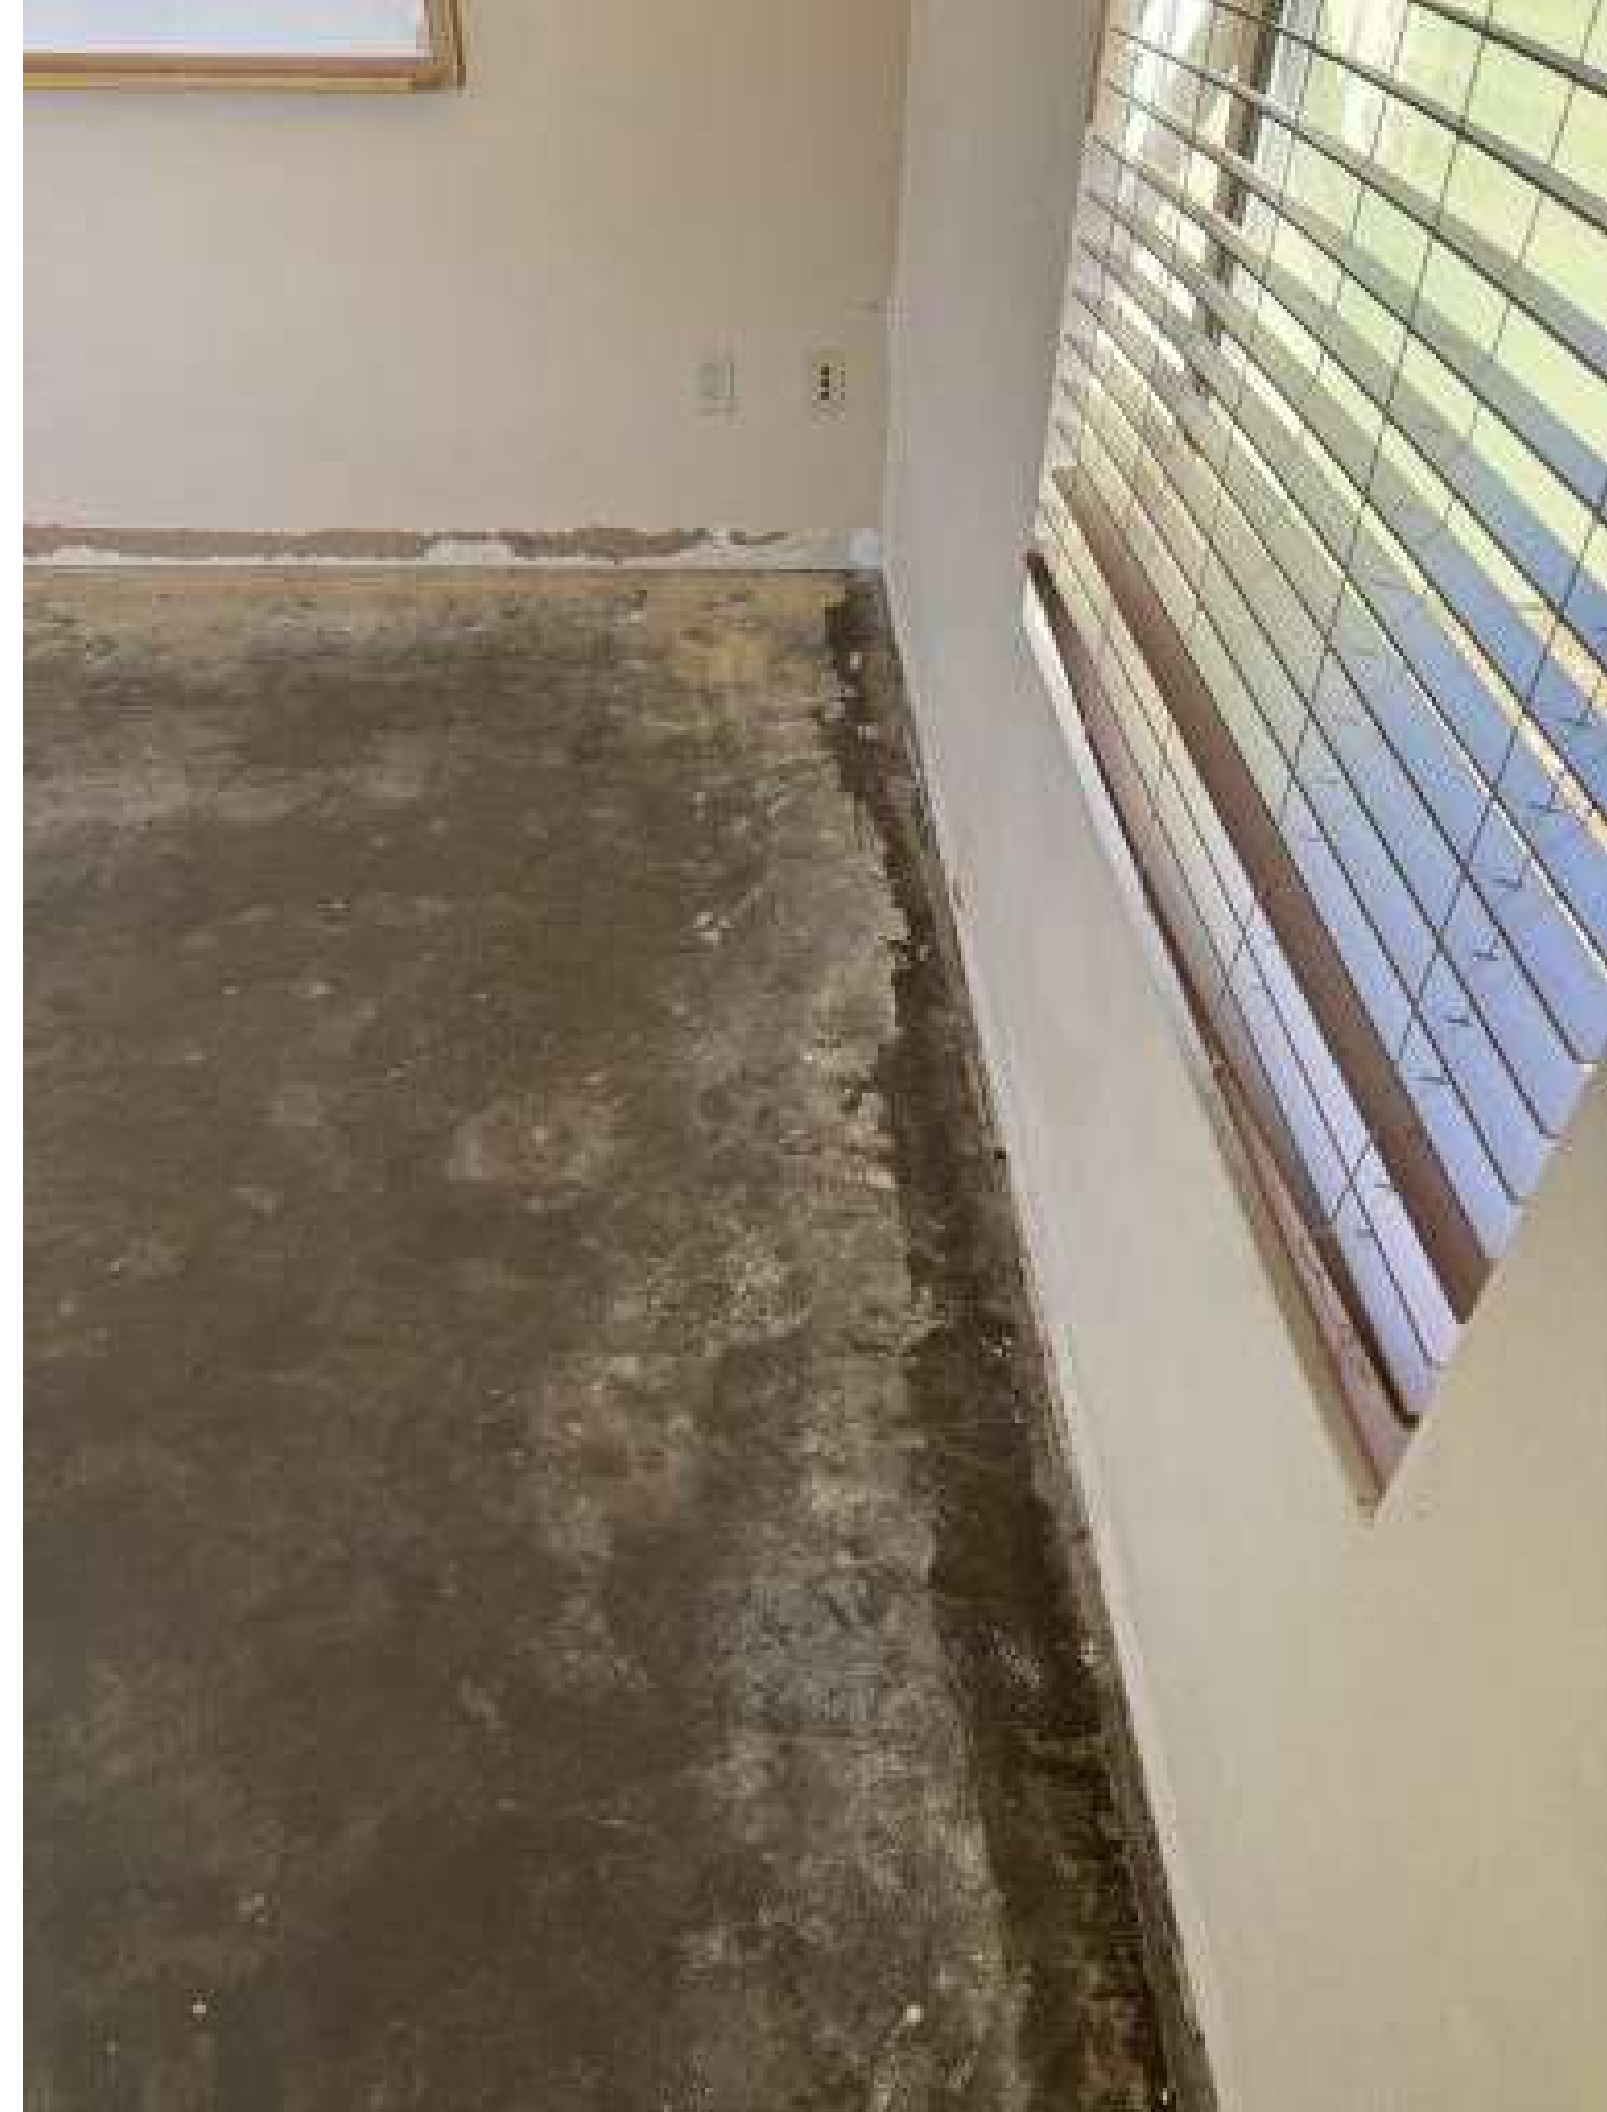
SEPARATION FROM  
STEM WALL AND SOG

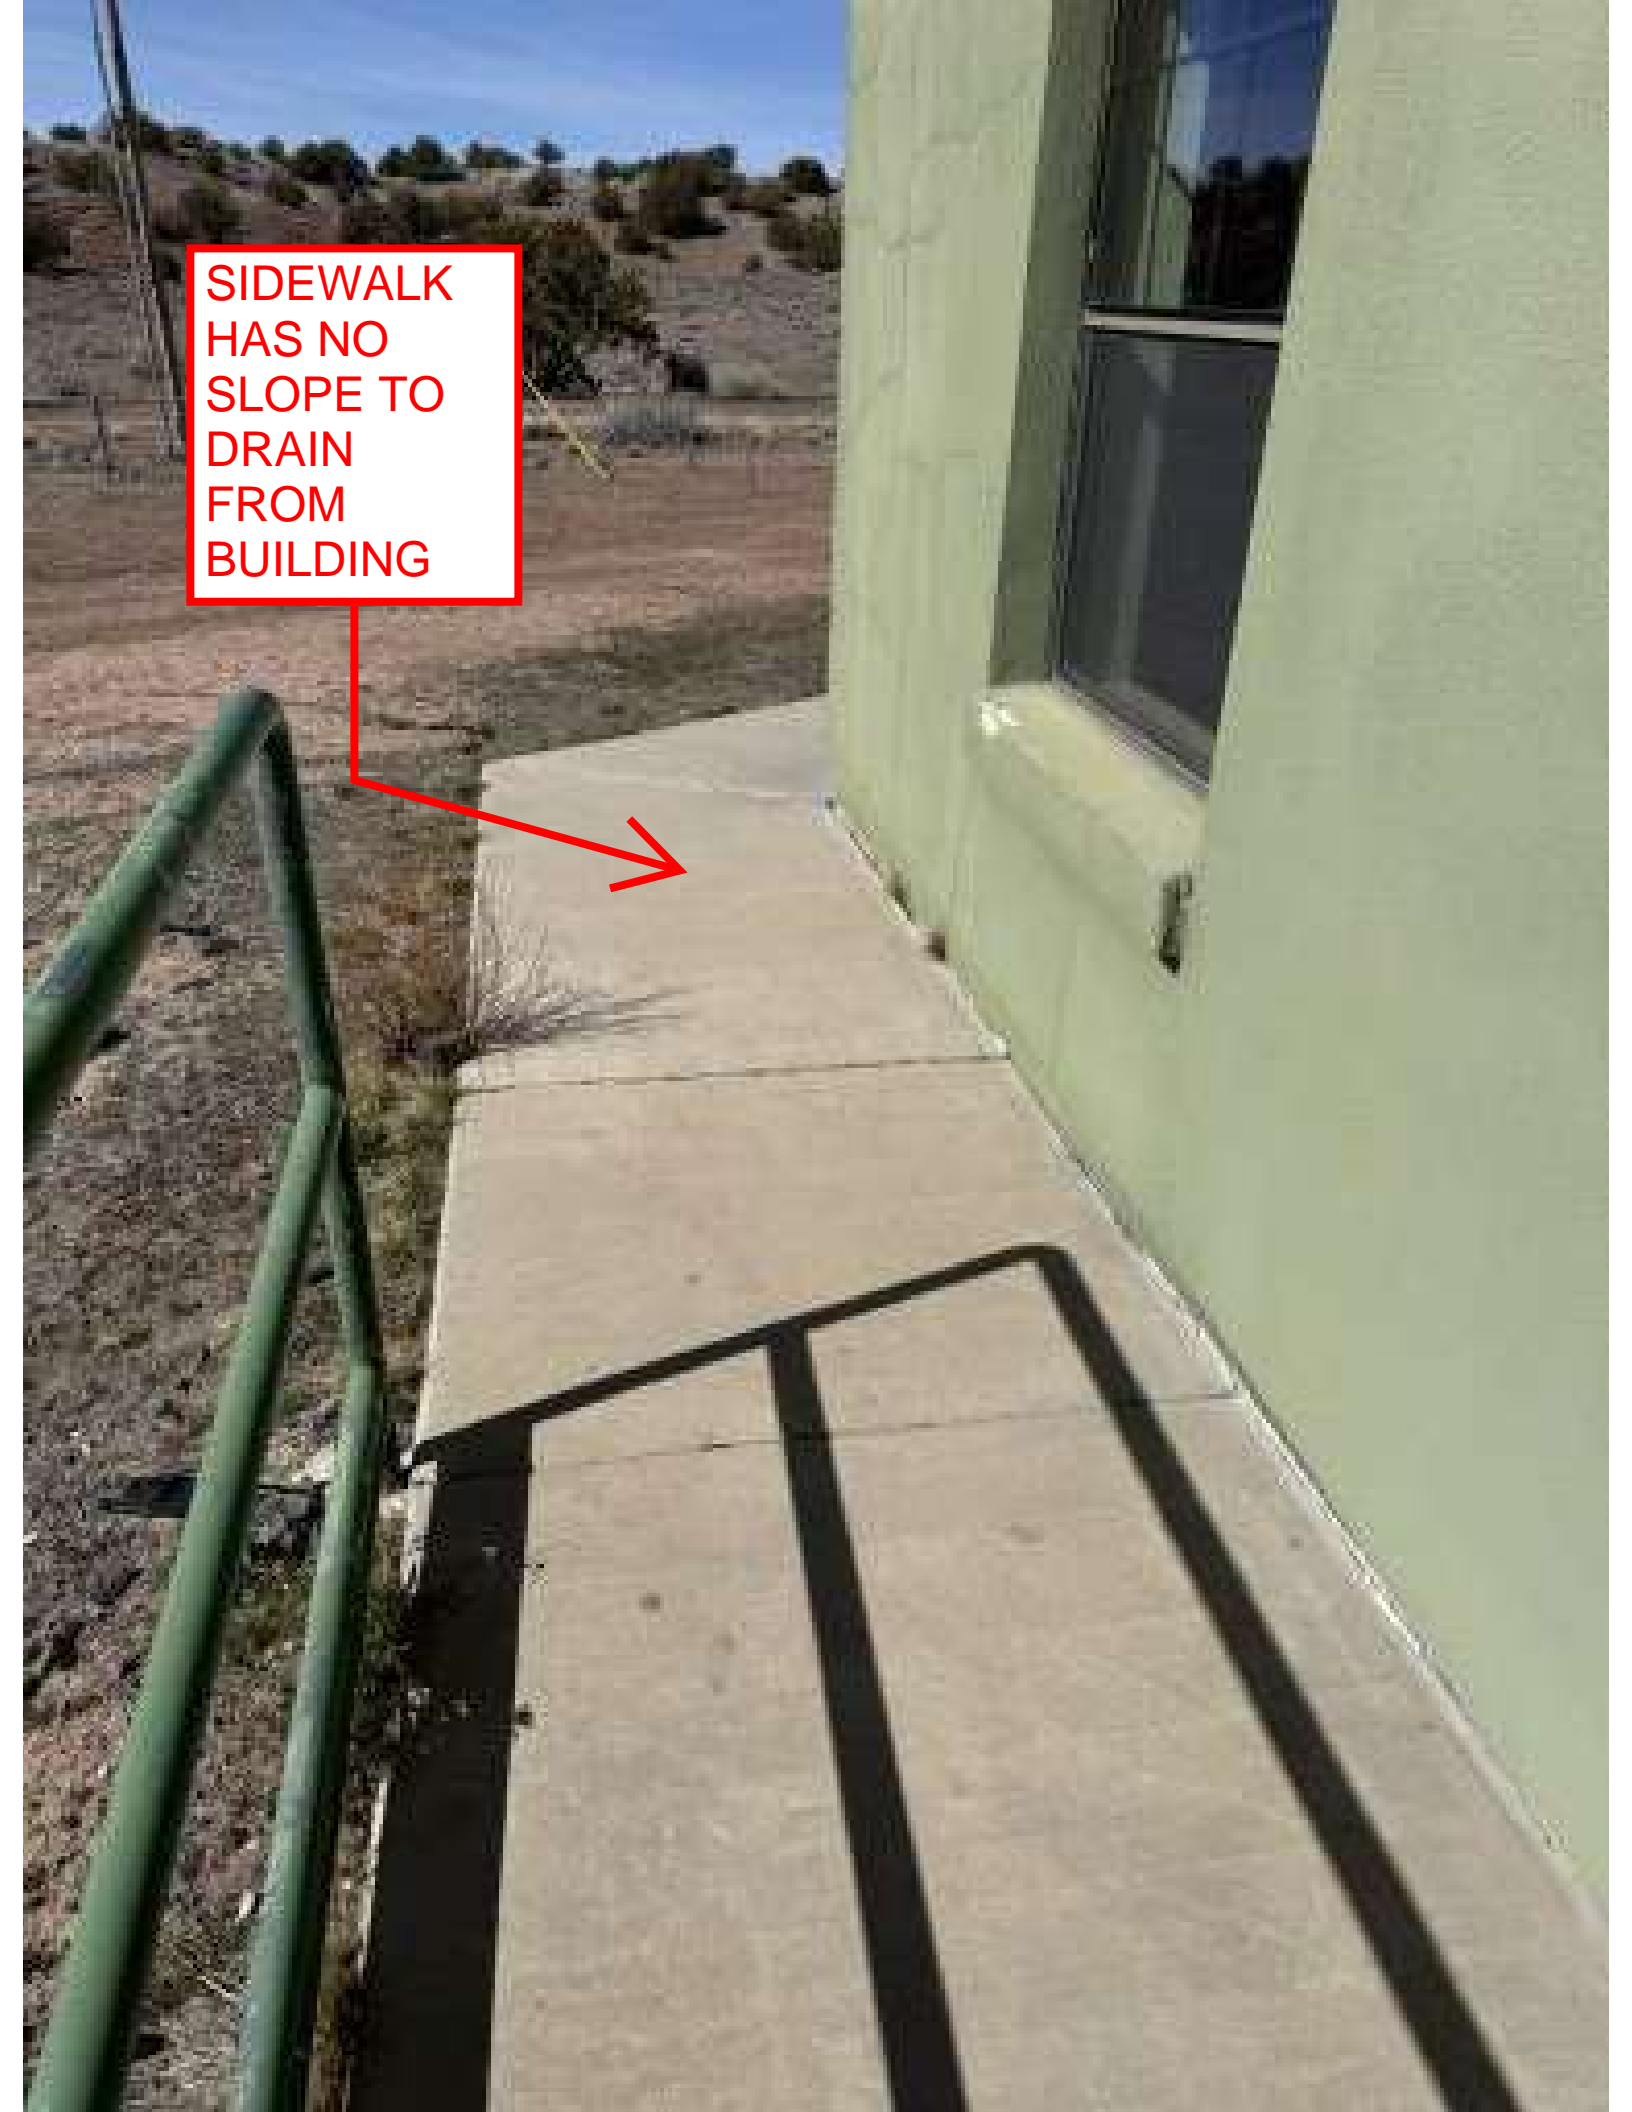
SIDEWALK  
HAS NO  
SLOPE TO  
DRAIN  
FROM  
BUILDING

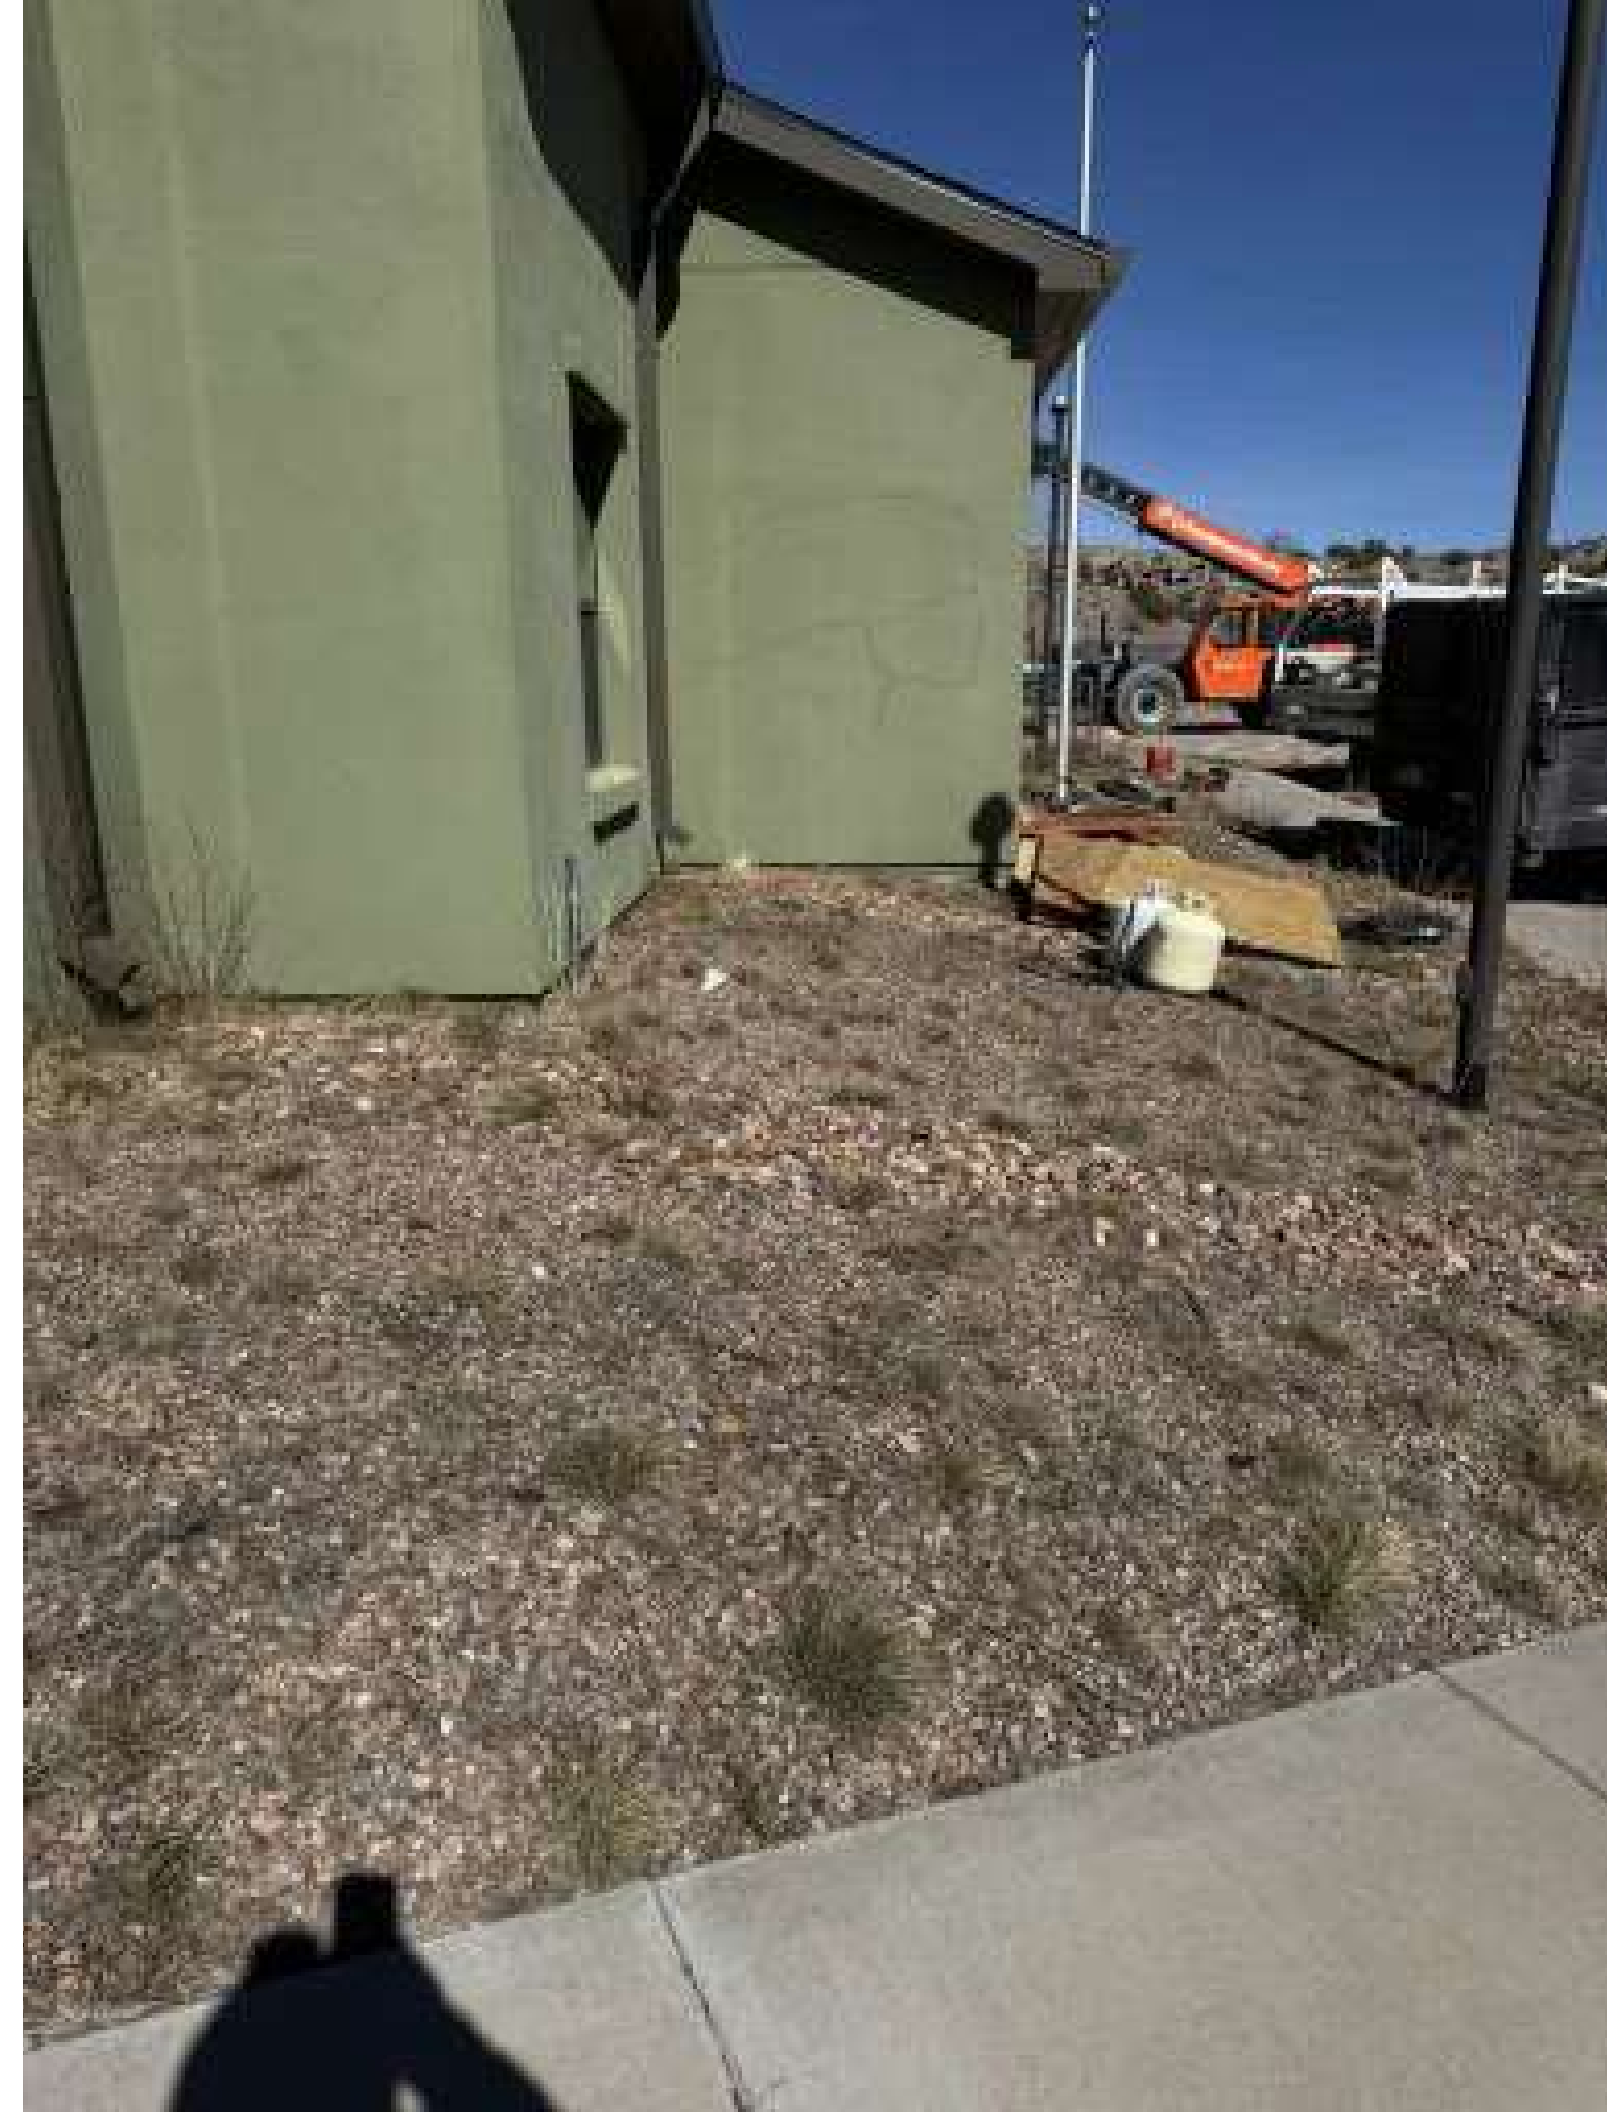
NO SLOPING  
GRADE OR  
DRAINAGE

- WYCO E&C recommends installing perforated pipes along the North/West/East

landscaped areas, adjacent to the building. The existing dirt shall be compacted and sloping away from the building (at a minimum of 2% grade).

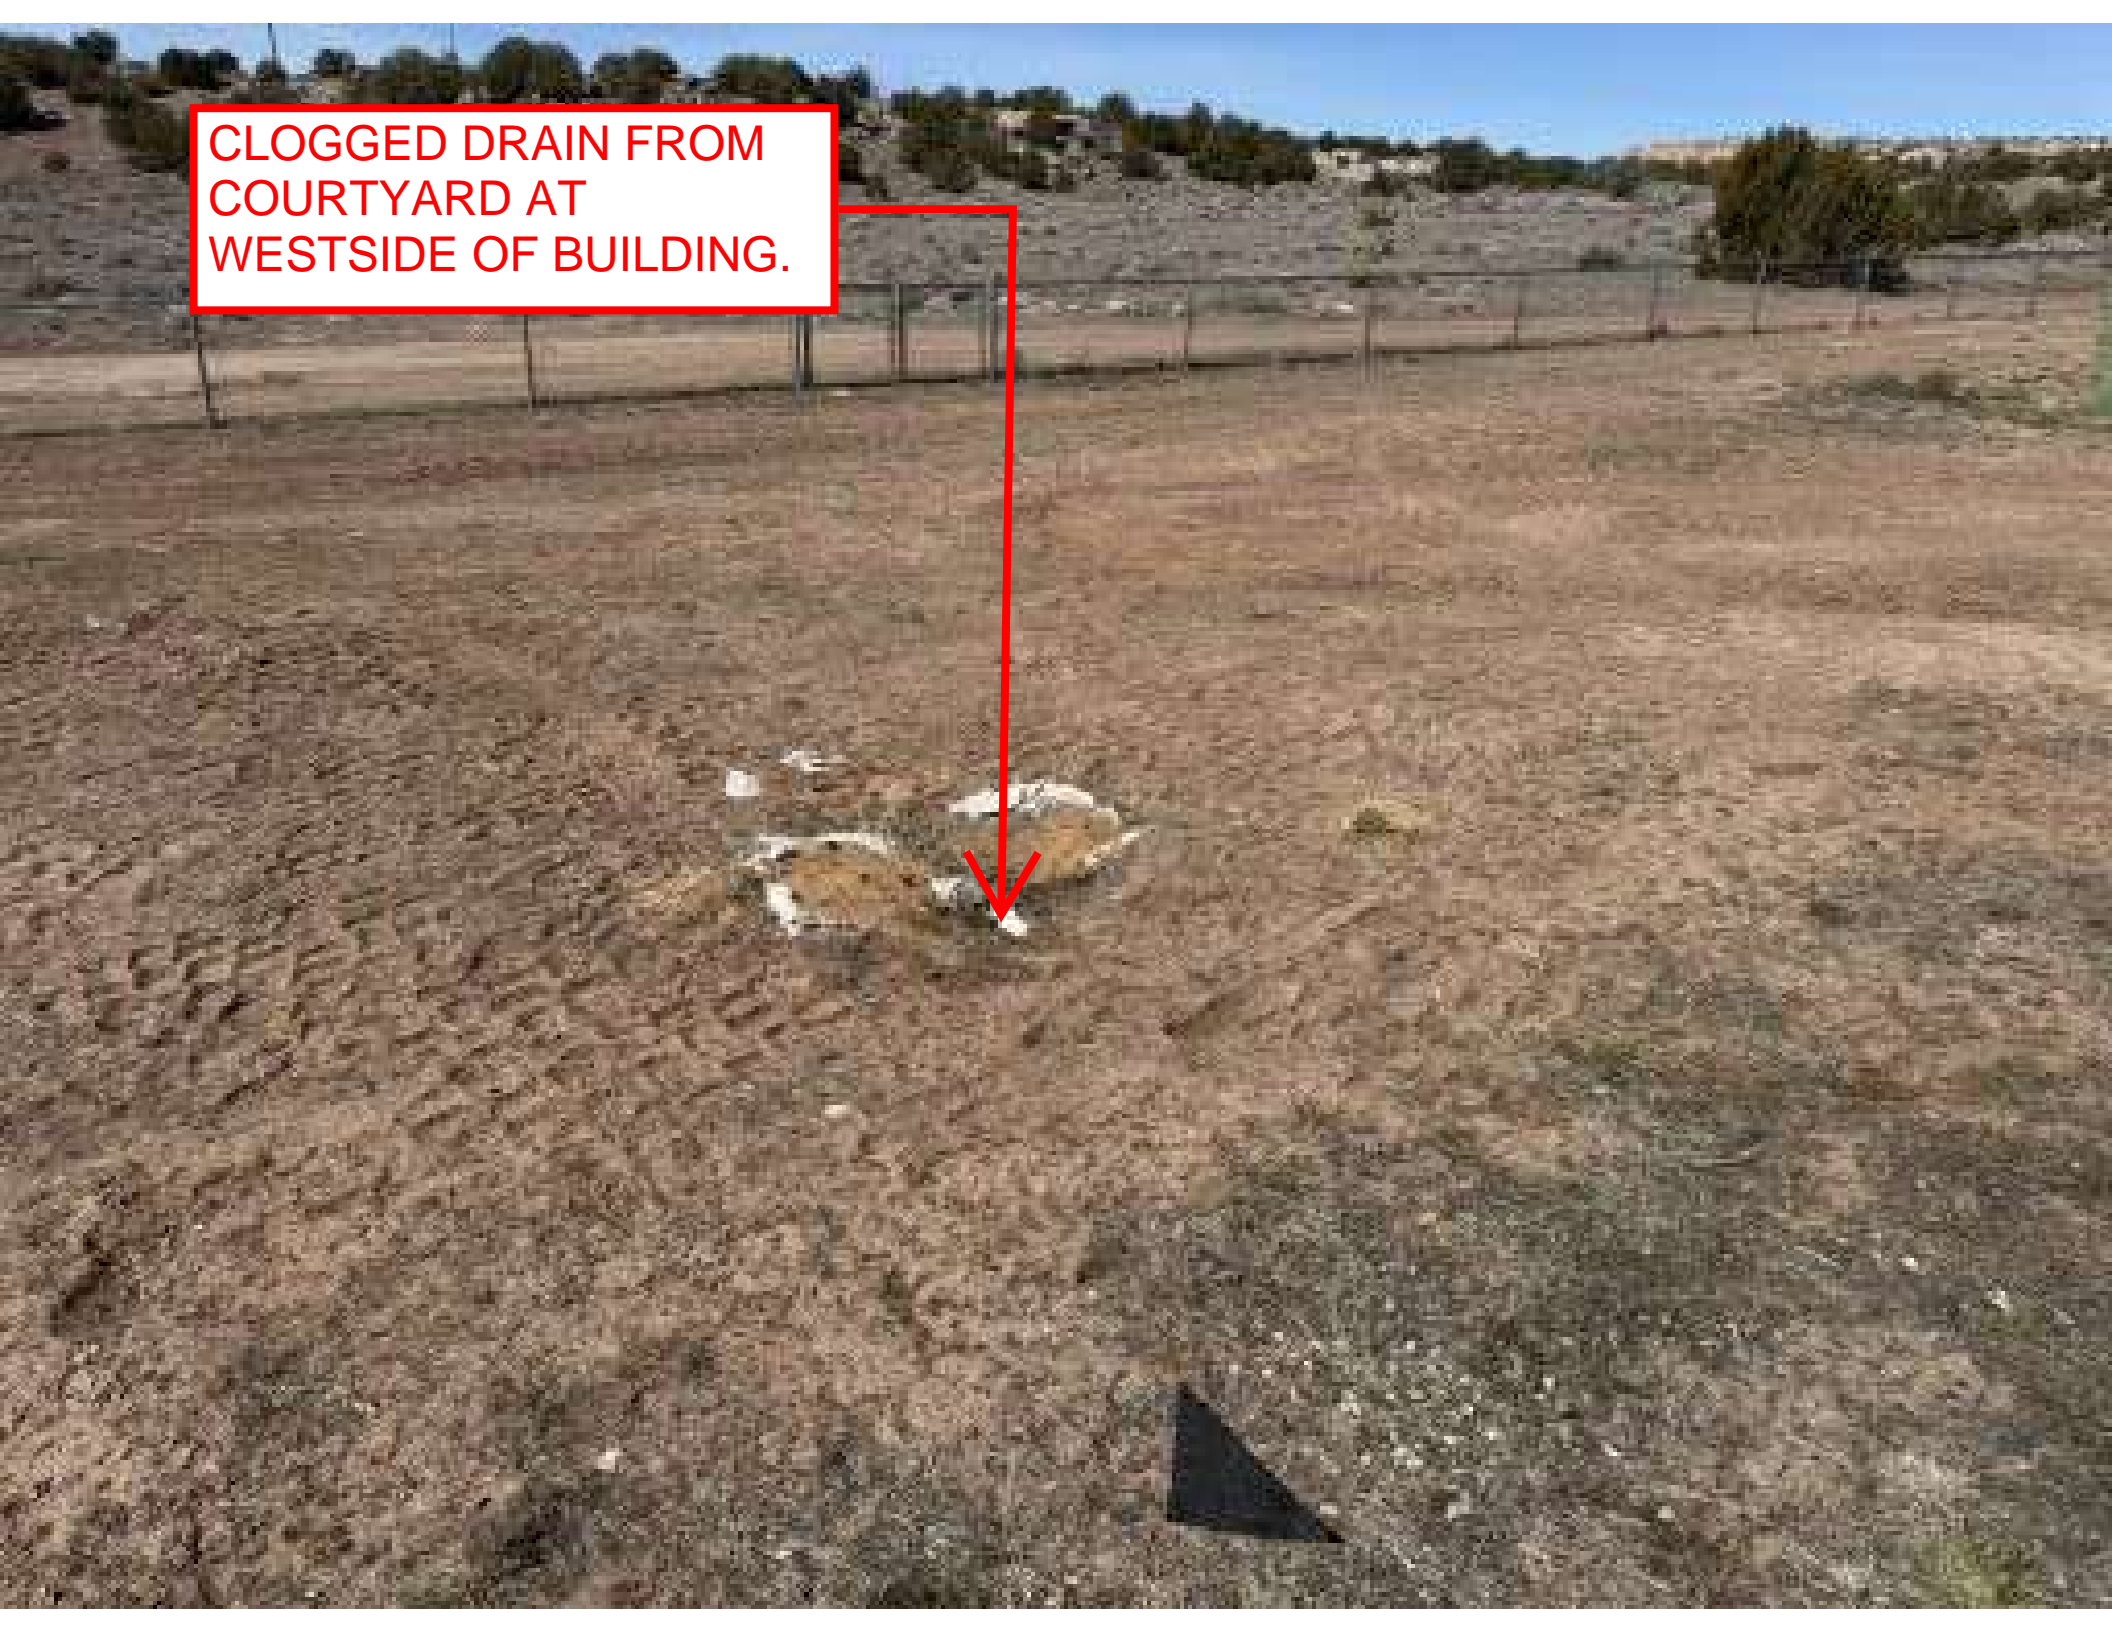
CLOGGED  
DRAIN,  
LEADS TO  
THE WEST

NO GRADE  
SLOPE

CLOGGED DRAIN FROM  
COURTYARD AT  
WESTSIDE OF BUILDING.

- Yearly maintenance of the landscaping is required. To clean out grates, pipes, and remove weeds.

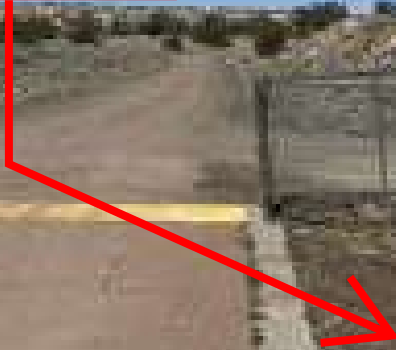
NO  
DRAINAGE  
AT HEADER  
CURB
