**CLIENT:** Sage Memorial Hospital  
SR 264 & Hwy 191  
Ganado, AZ 86505

**PROJECT:** Sage Memorial Hospital – Structural Investigation – Group Home Assessment

**PROJECT NO.:** 2026-008-001

**REPORT DATE:** March 5, 2026

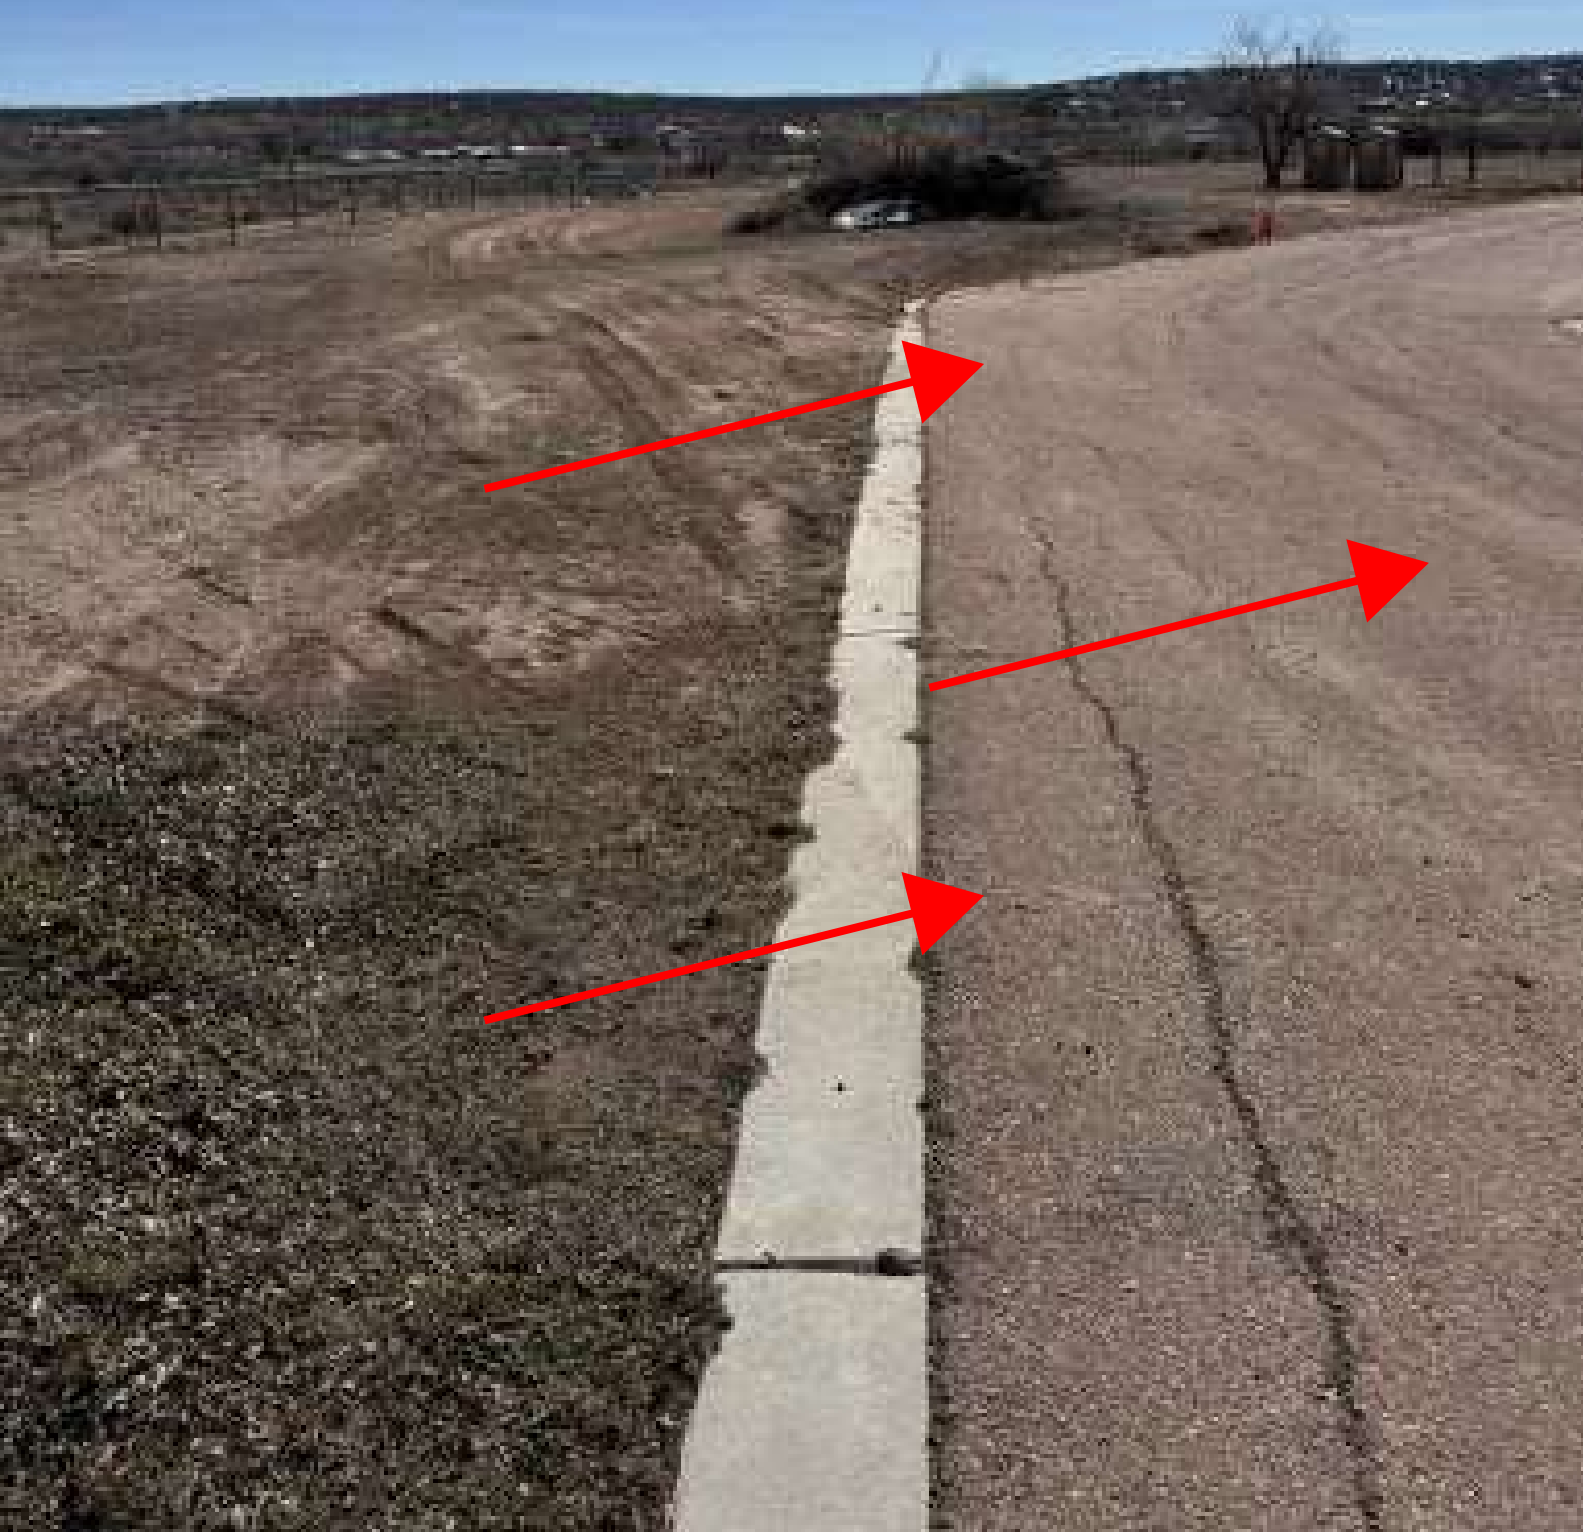
ALL DRAINAGE  
SLOPING TO  
BUILDING

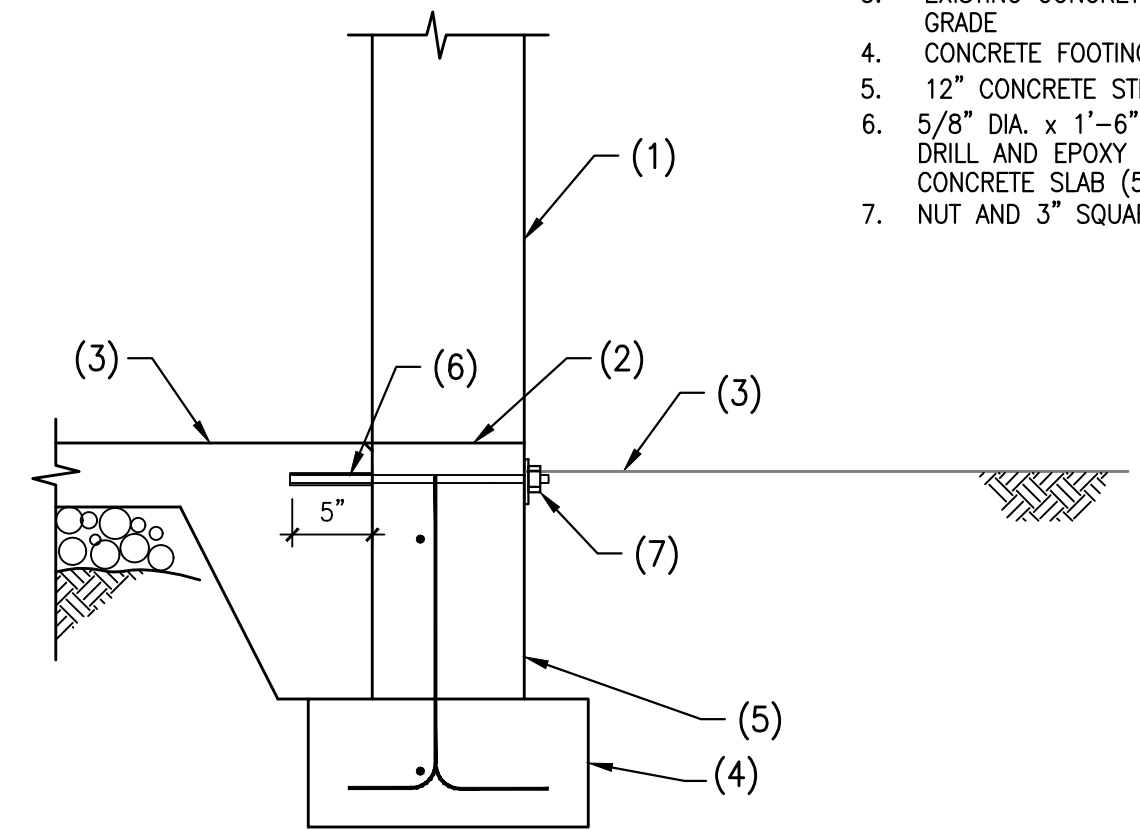
SK2 CONCRETE STEM WALL TO SOG CONNECTION  
 SCALE: NOT TO SCALE

detail, 'Typical Wall Section' Detail does not specify any dowels from the concrete turndown of the slab-on-grade (SOG) to the Concrete Stem Wall.

1. Concrete Stem Wall/SOG Gap Condition: See Sketch
  - The exterior of the building will need to dug out and demolition of existing sidewalk will be required for fix. The Concrete Stem Wall will then be drilled through and a minimum of 6" in the Slabs Toe-Down and infilled with Structural Epoxy. Next, a 5/8" diameter threaded rod will need to be installed, minimum embedment of 6" will be required, and WYCO E&C require \*SSI Report for proper installation of epoxy. After the epoxy has cured, a washer and nut will be installed and torqued to close the Wall and SOG. All metals shall be galvanized to prevent any rust.

- NOTES:
- ICF WALL
  - TOP OF ADJACENT CONCRETE STEM WALL
  - EXISTING CONCRETE SOG OR GRADE
  - CONCRETE FOOTING
  - 12" CONCRETE STEM WALL
  - 5/8" DIA. x 1'-6" LONG AT 5'-0" O.C. DRILL AND EPOXY INTO EXISTING CONCRETE SLAB (5" EMBED).
  - NUT AND 3" SQUARE STEEL WASHER
