**CLIENT:** Sage Memorial Hospital  
SR 264 & Hwy 191  
Ganado, AZ 86505

**PROJECT:** Sage Memorial Hospital – Structural Investigation – Group Home Assessment

**PROJECT NO.:** 2026-008-001

**REPORT DATE:** March 5, 2026

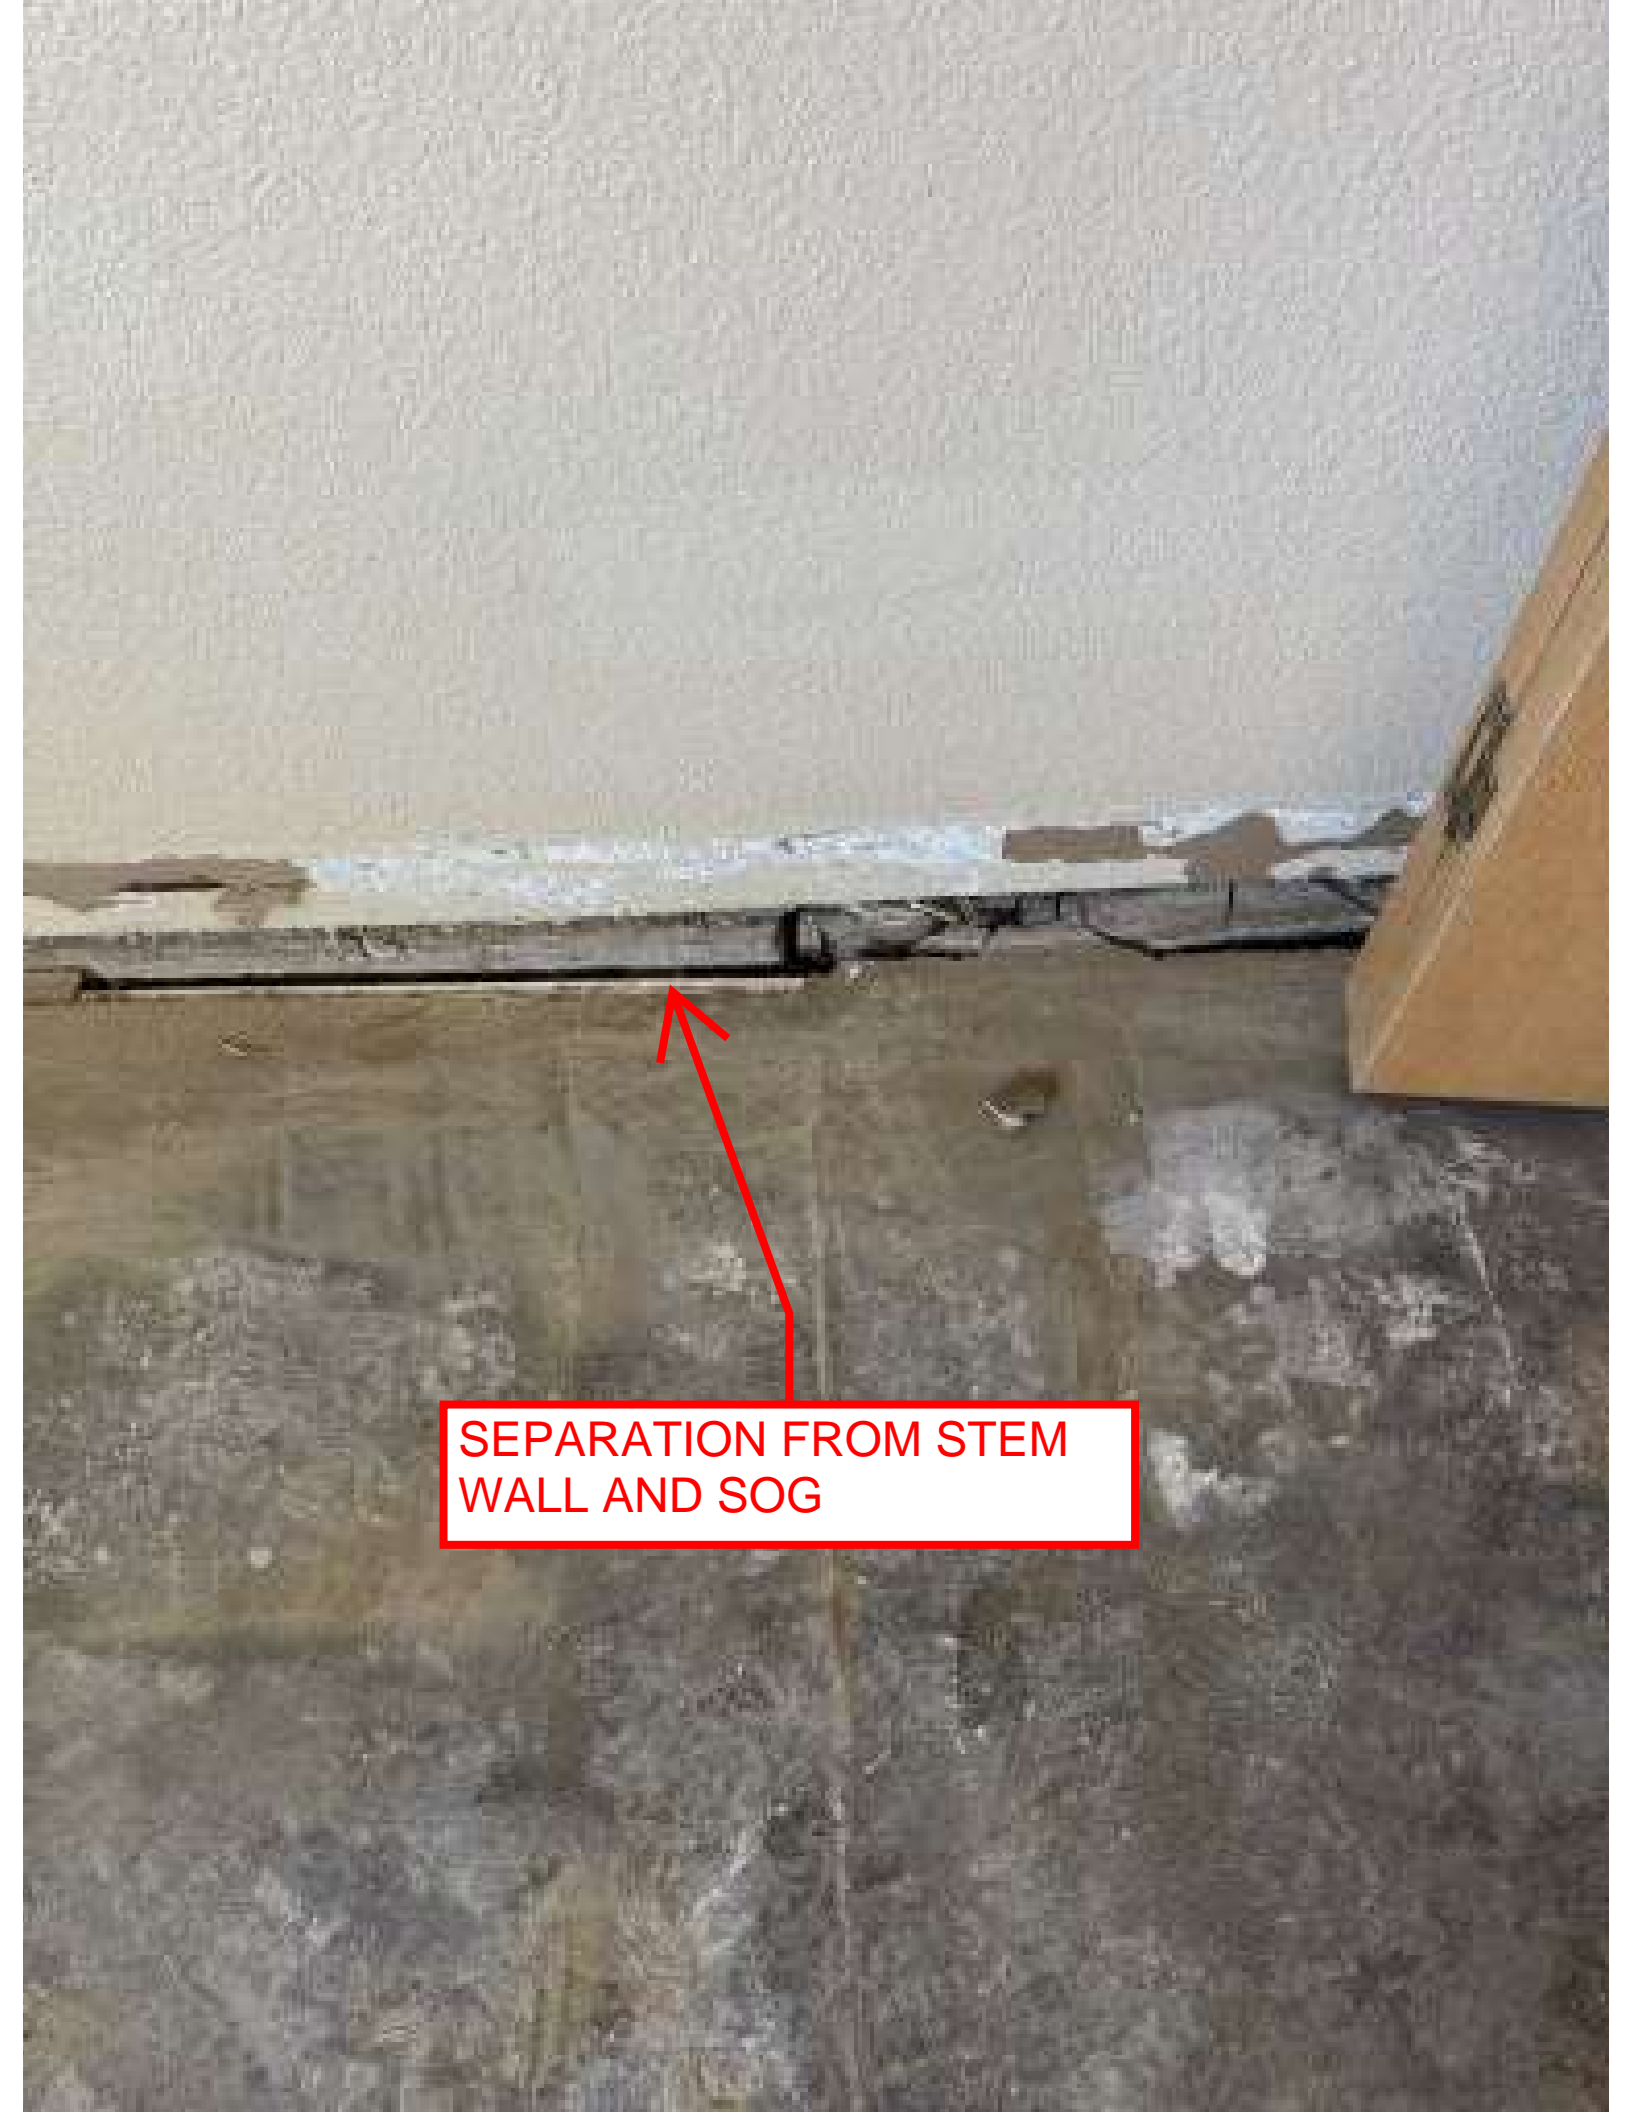
SEPARATION FROM STEM  
WALL AND SOG

1. Concrete Stem Wall/SOG Gap Condition: See Sketch
  - The exterior of the building will need to dug out and demolition of existing sidewalk will be required for fix. The Concrete Stem Wall will then be drilled through and a minimum of 6" in the Slabs Toe-Down and infilled with Structural Epoxy. Next, a 5/8" diameter threaded rod will need to be installed, minimum embedment of 6" will be required, and WYCO E&C require \*SSI Report for proper installation of epoxy. After the epoxy has cured, a washer and nut will be installed and torqued to close the Wall and SOG. All metals shall be galvanized to prevent any rust.

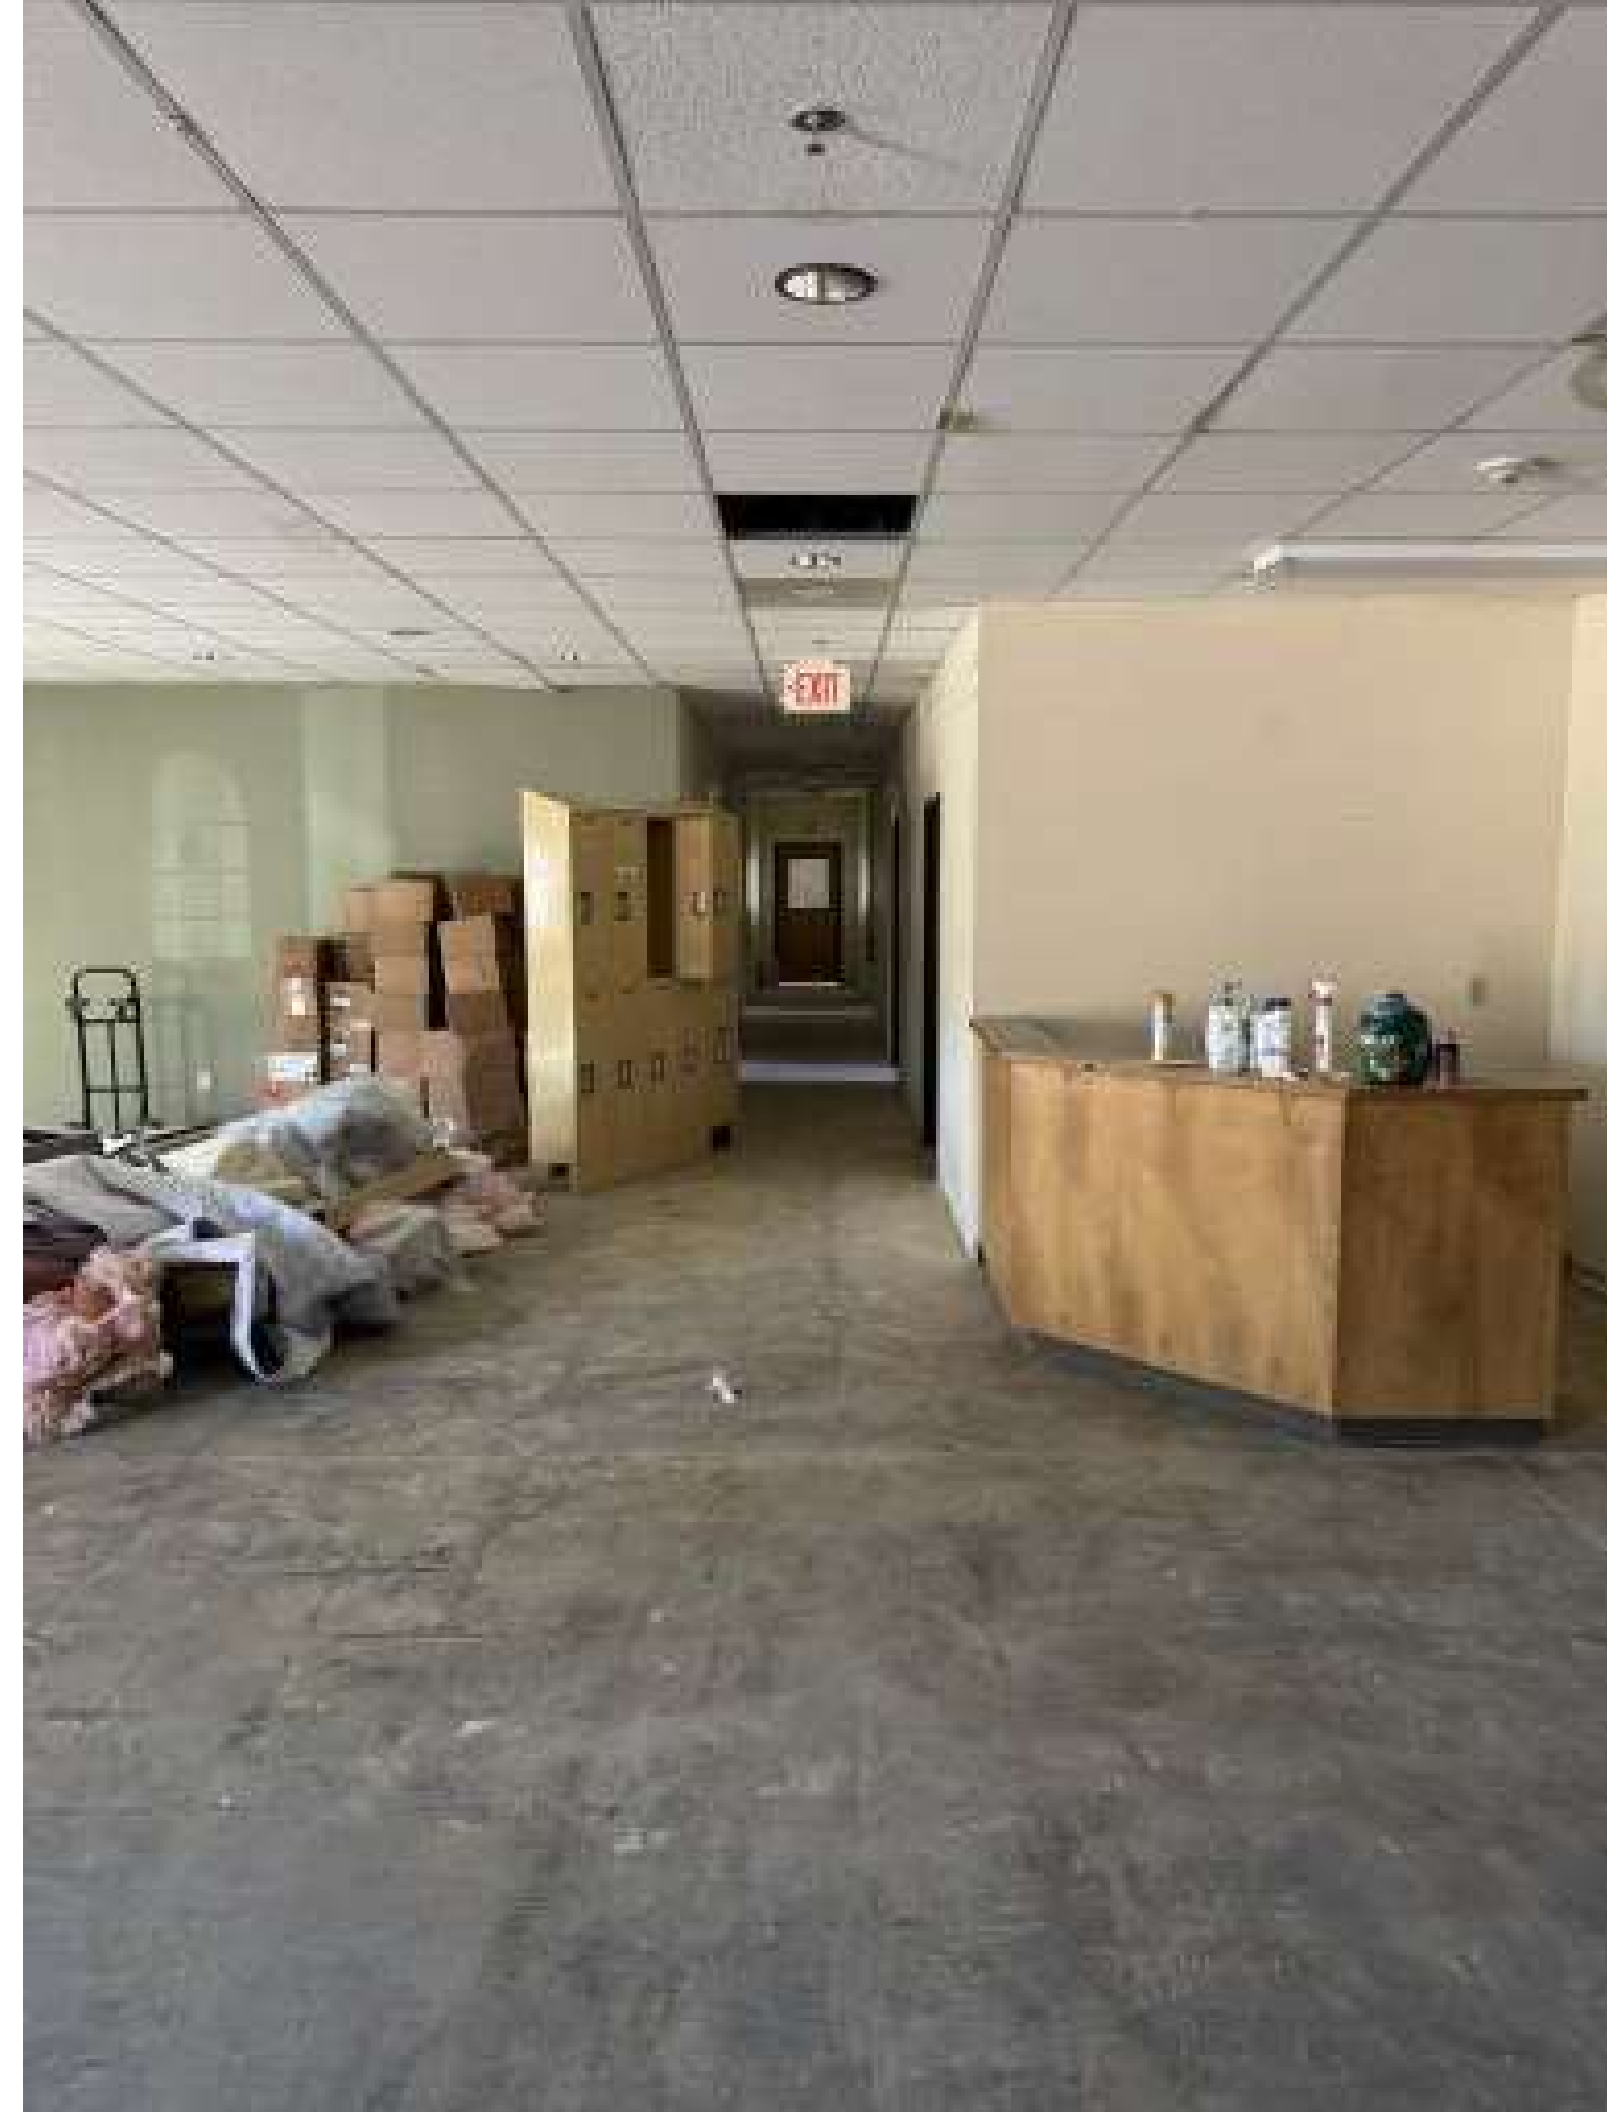
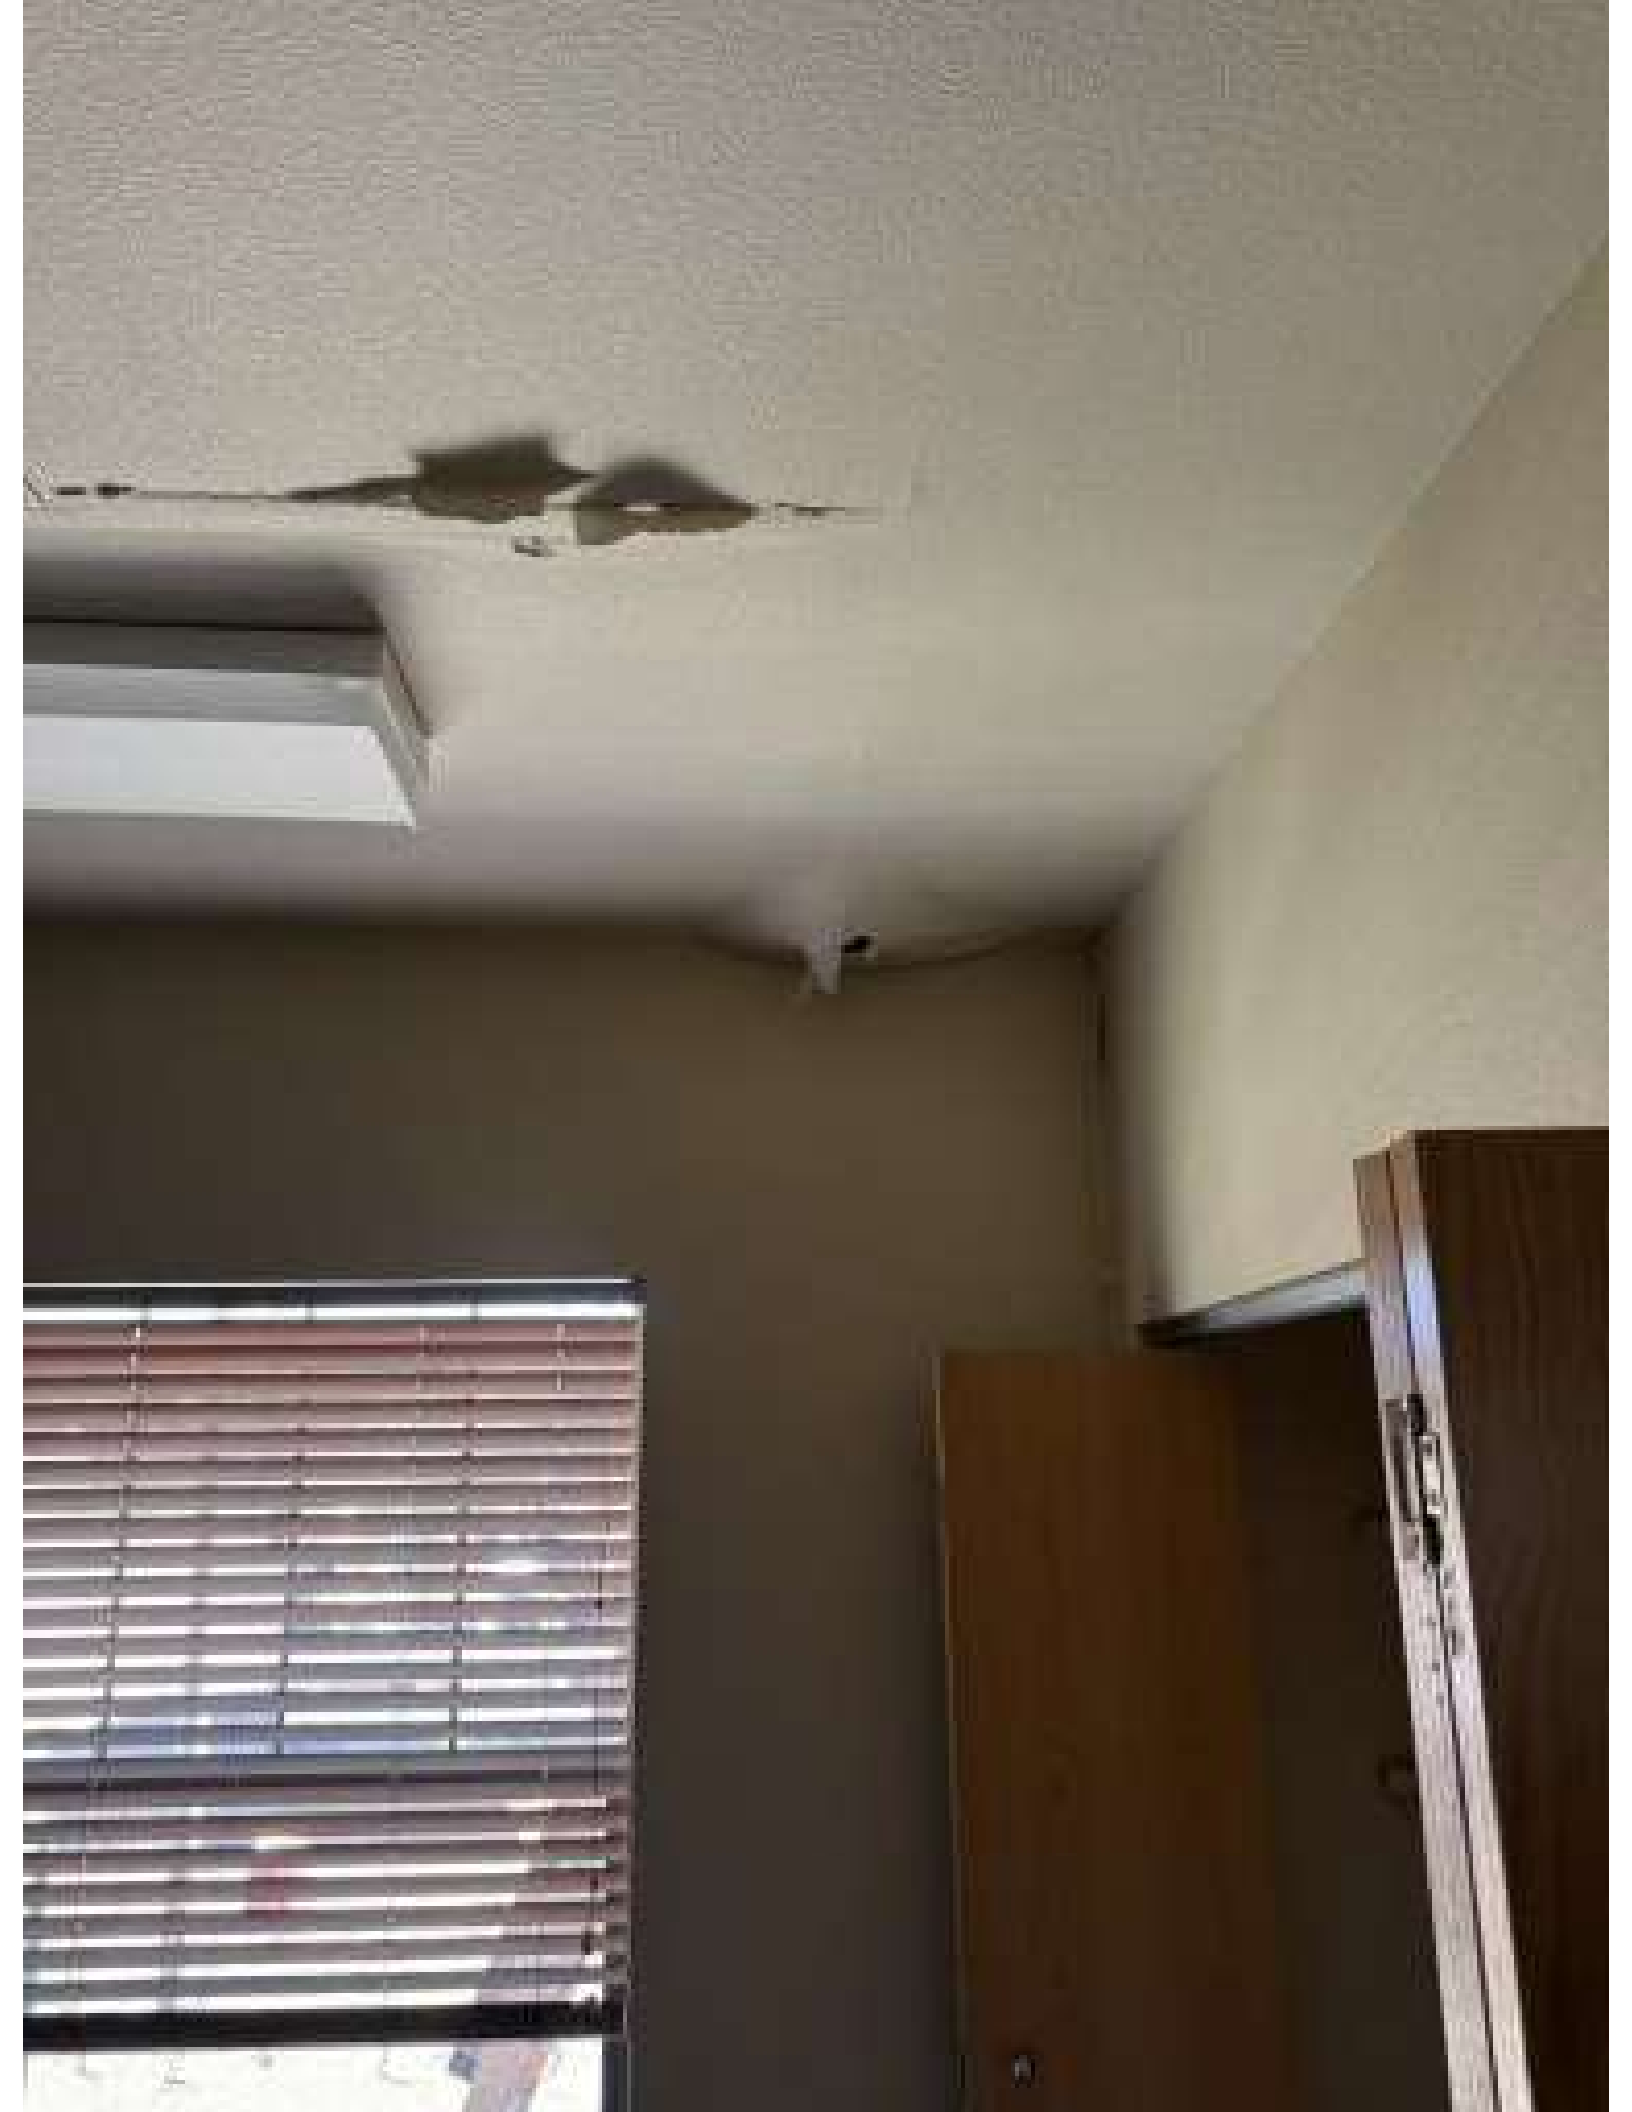
SEPARATION FROM  
STEM WALL AND SOG

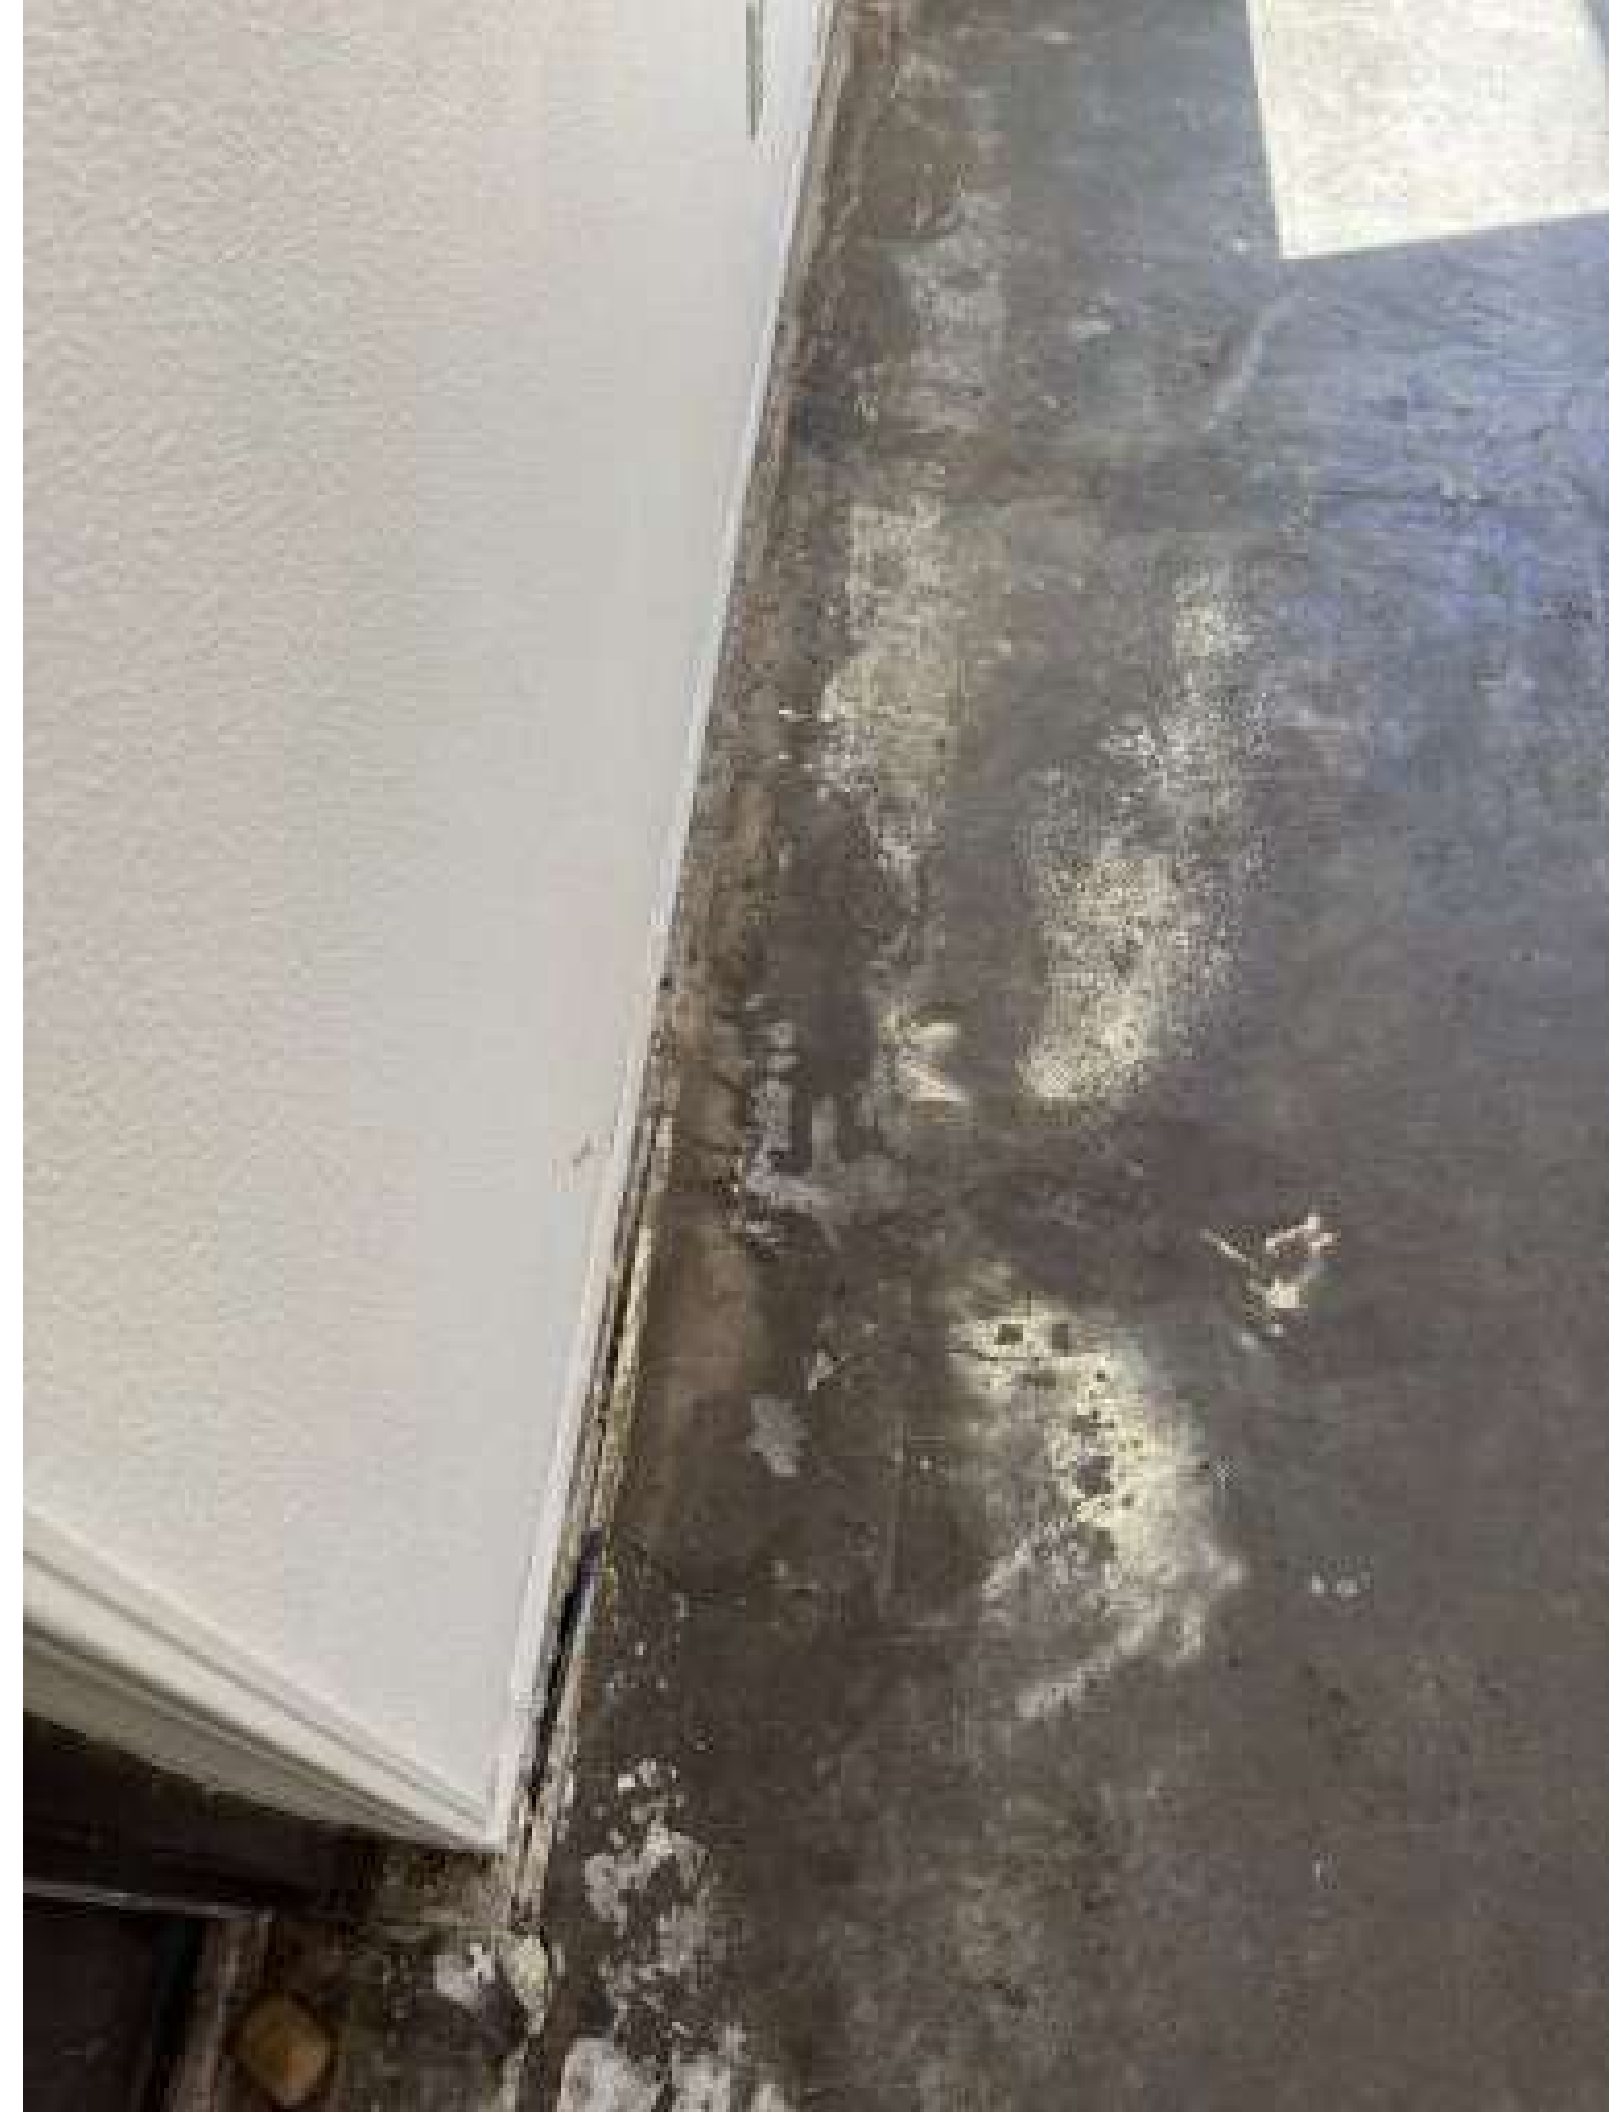
SIDEWALK  
HAS NO  
SLOPE TO  
DRAIN  
FROM  
BUILDING

3. Exterior Drainage: See photos of drainage issues.
  - To avoid any further soil settlement/movement.
    - WYCO E&C recommends removing the entryway stones. Import suitable soil and level the stones to match the door entry, or place concrete with scupper.

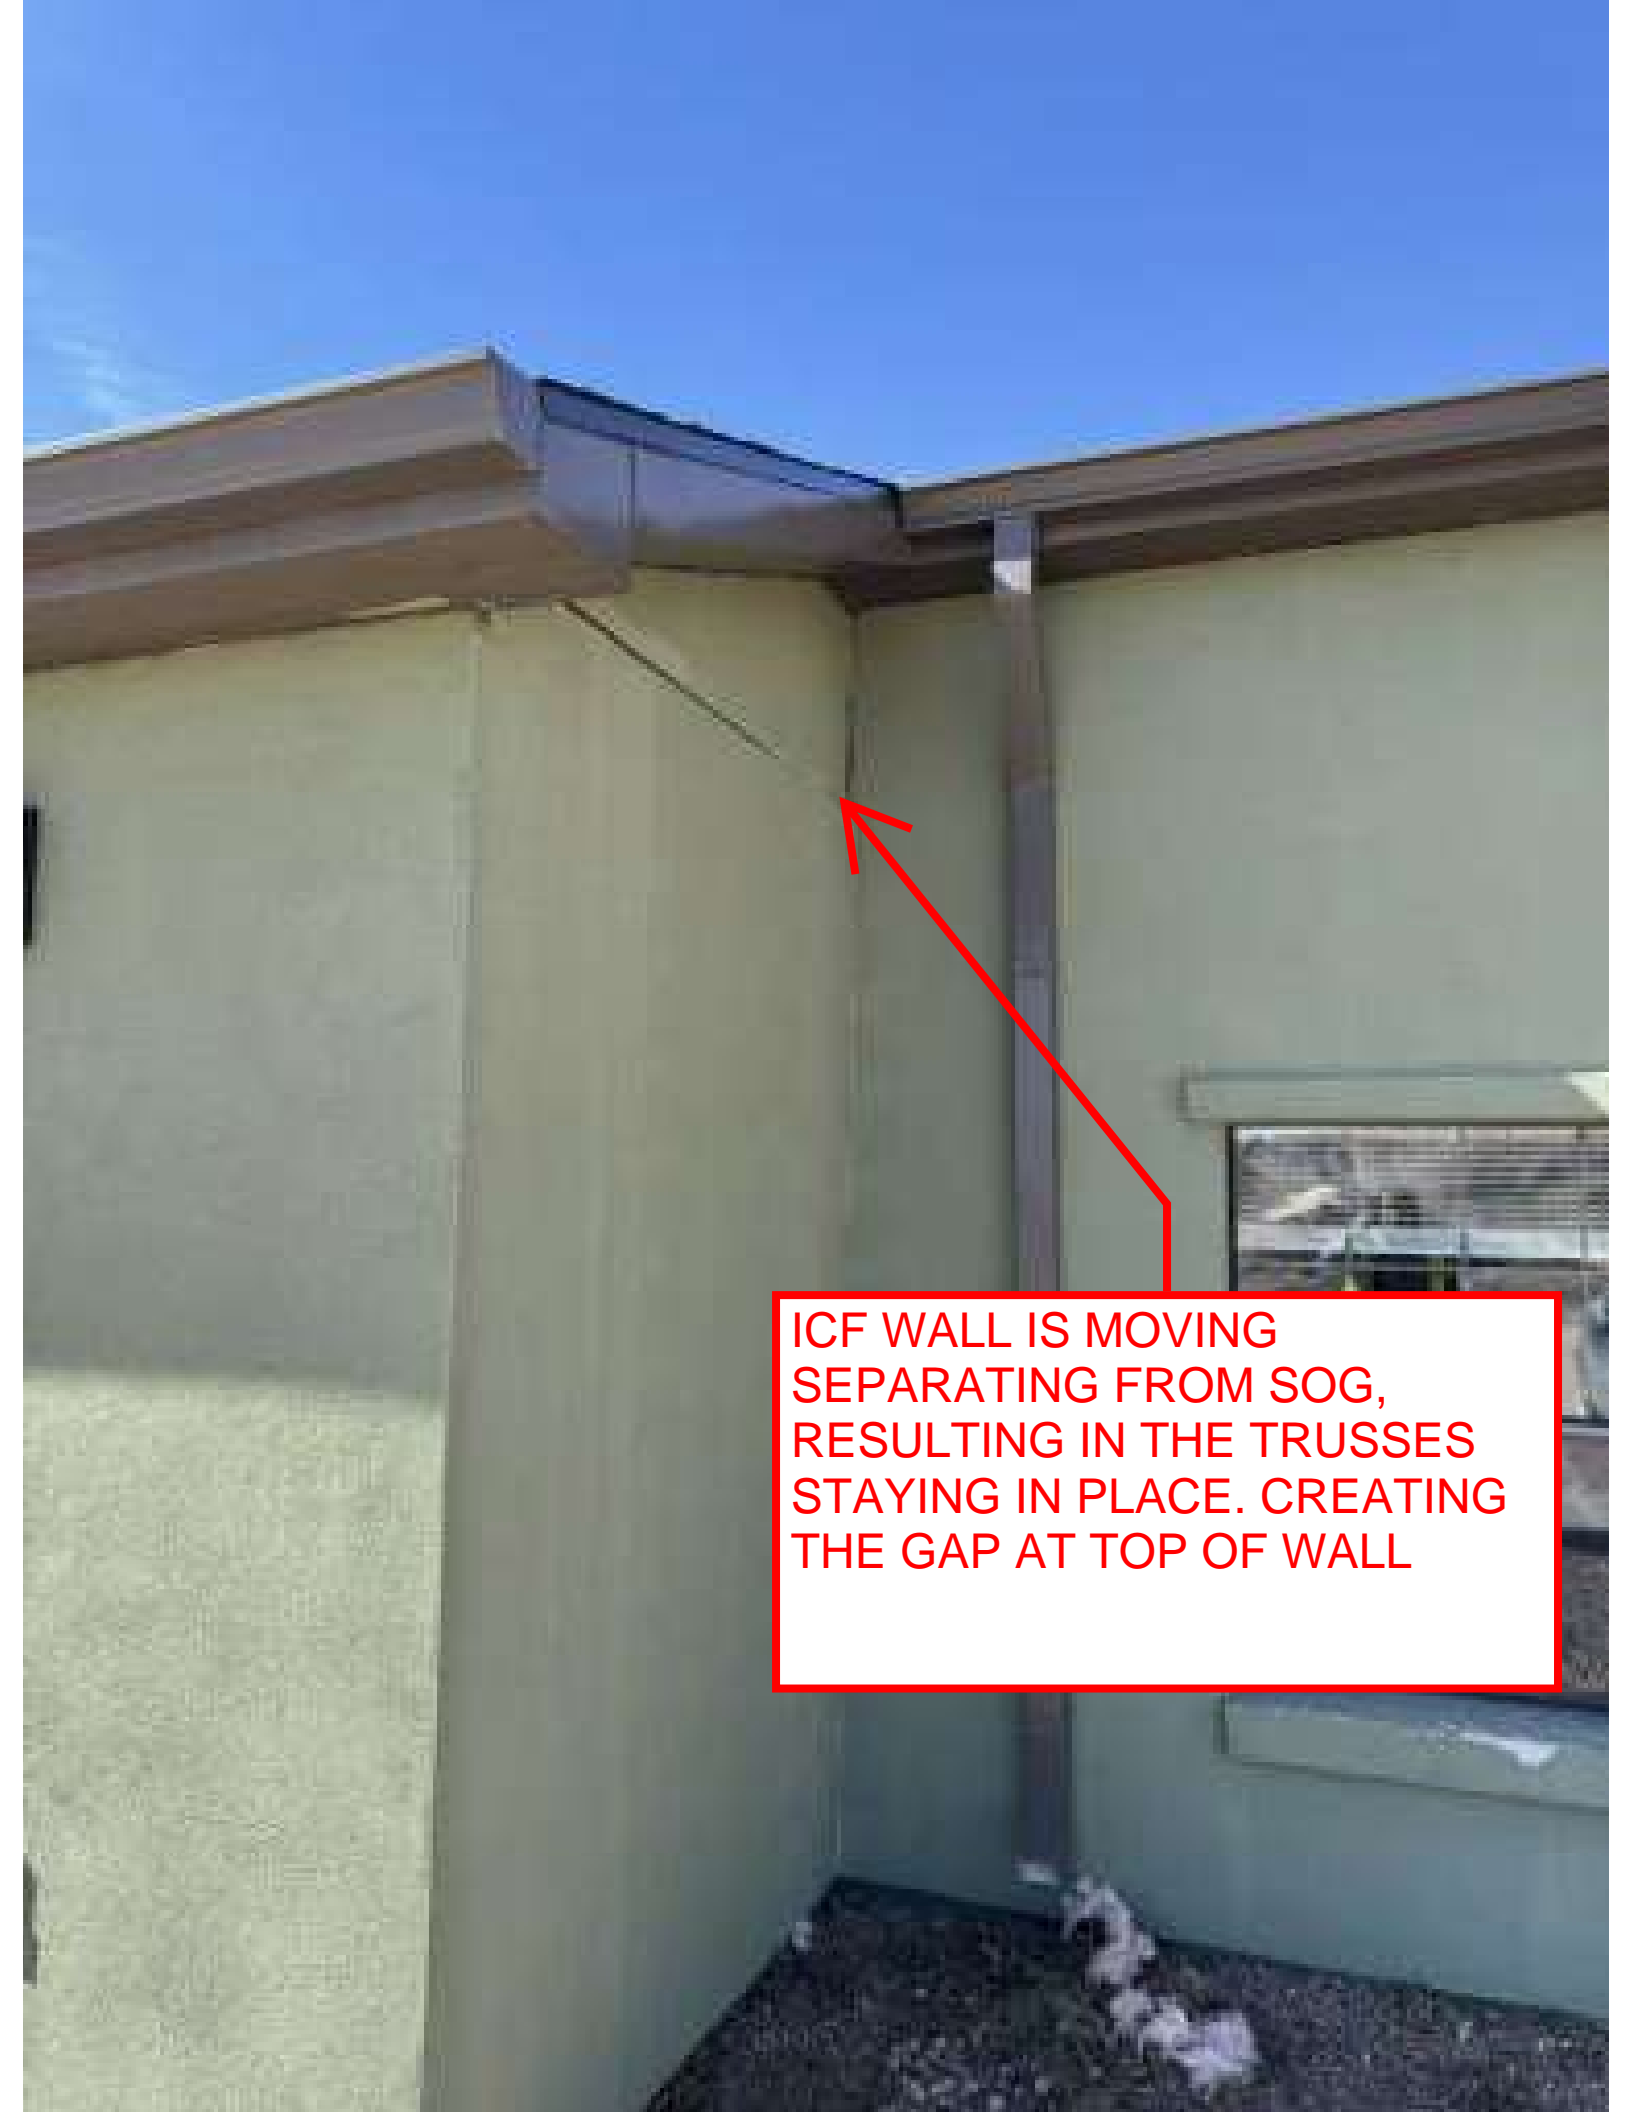
ICF WALL IS MOVING  
SEPARATING FROM SOG,  
RESULTING IN THE TRUSSES  
STAYING IN PLACE. CREATING  
THE GAP AT TOP OF WALL
